COS
Monthly Status Review
July 25, 2001
GSFC

UCB FUV01 Detector Post Thermal Vacuum Issues

FUV Detector Door Mechanism Summary

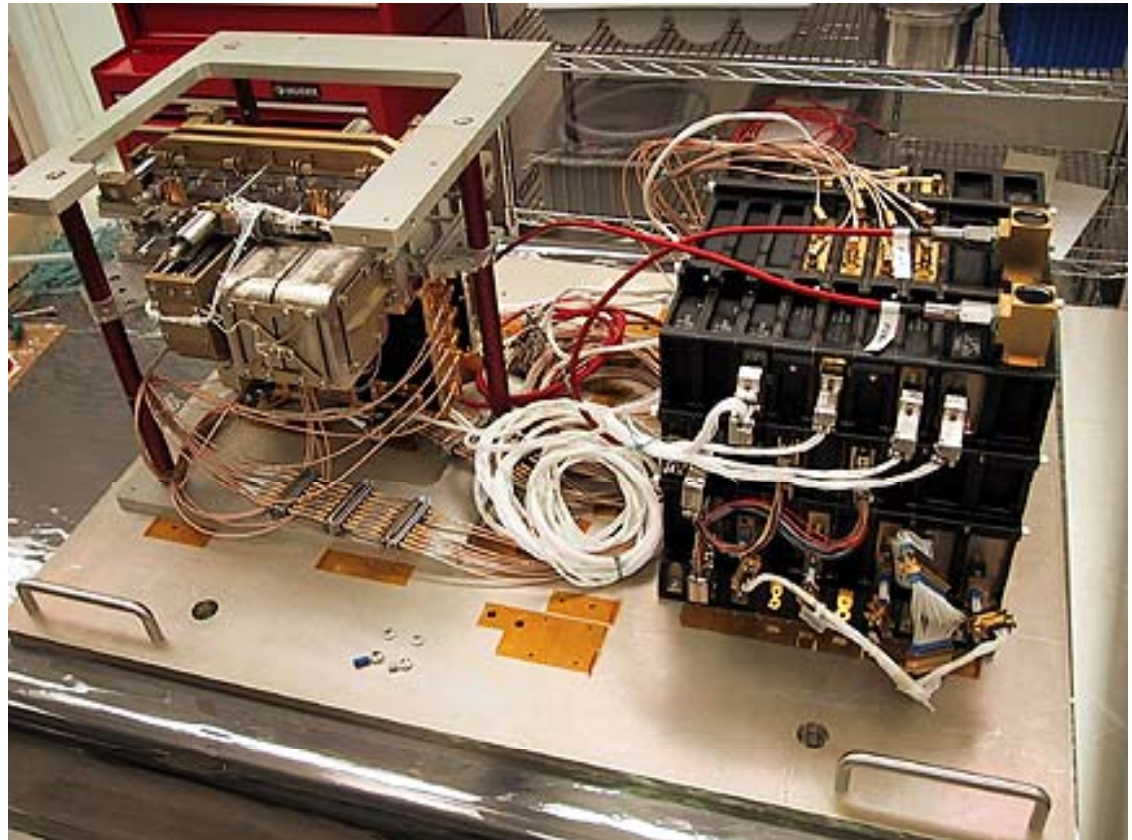
FUV01 Flight Unit

Detector on optics bench with
upper door & mechanism
removed

Detector upper door &
mechanism at UCB for rework

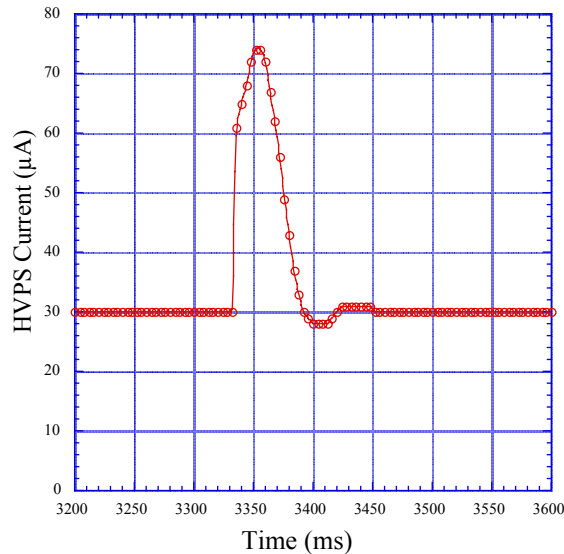
Lab study - HV transient example
Large saturated event and HVI transient

- **High Voltage Current Transient (Study presented at March 01 monthly)**
 - Newly released flight software (v. 1041) uses a 60 ms (from 20 ms) persistence for the HV current limit task. This will significantly reduce the occurrence of HVI shutdowns, as 20 ms is the characteristic time of most transients. This should eliminate shutdowns from harmless transients while maintaining protection against real HV overcurrents.

COS non-trip HVI transient (threshold = 120), event spontaneously decays away

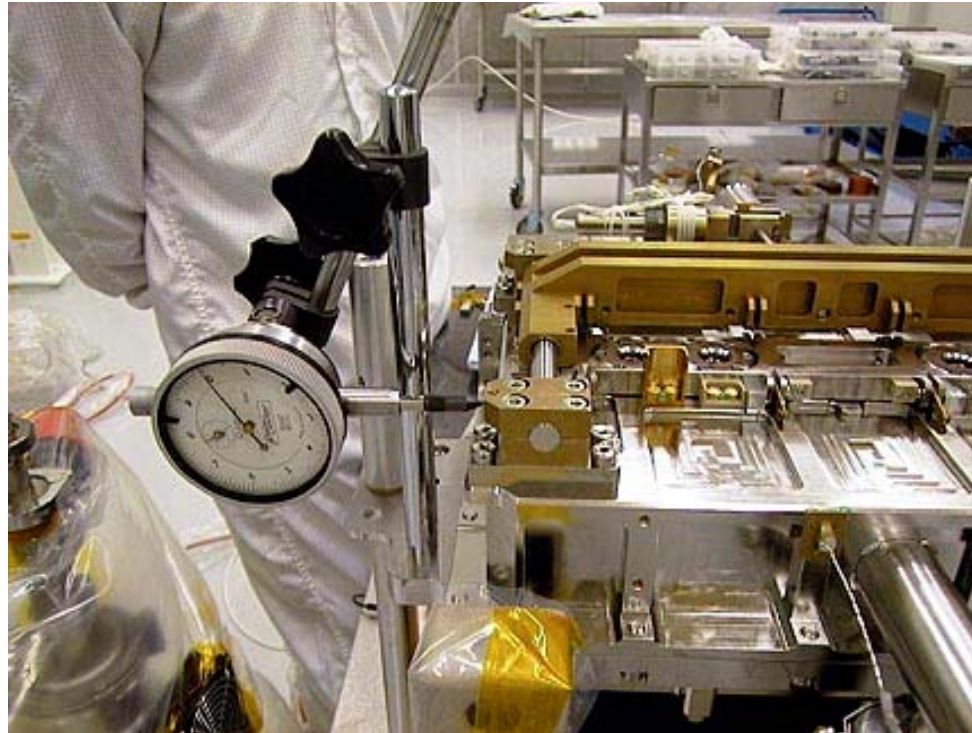
COS FUV01 Detector Door Disassembly Measurements

Many measurements of position and friction were made during disassembly. These show that the friction was too great for the backup system to open the door.

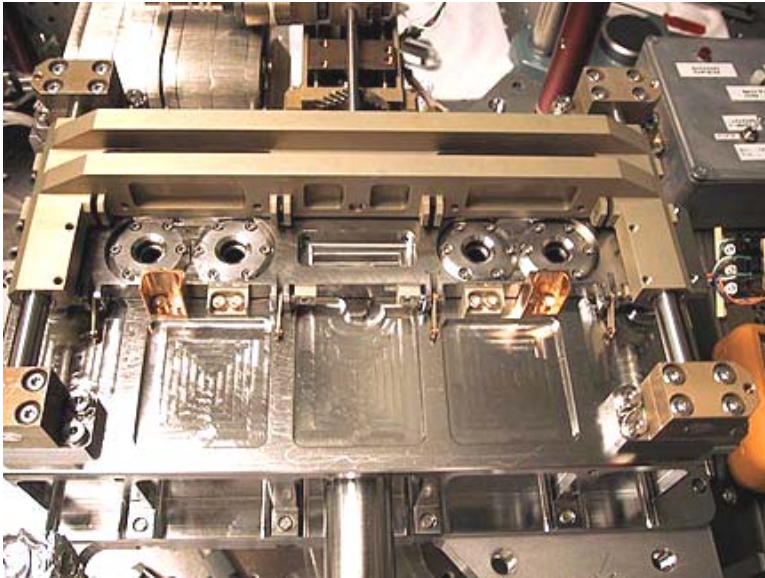
Carriage detached from lower door

Both FUV01 and FUV02 upper door assemblies were detached and removed while maintaining vacuum inside the DVA's. This allowed position and force measurements to be made. The door carriage could also slide along the rails permitting investigation of the problem.

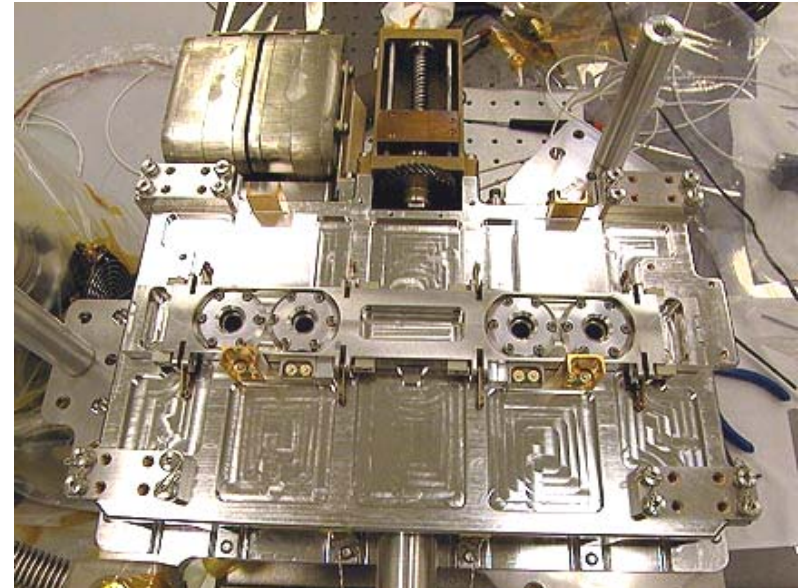
Door system removed from DVA

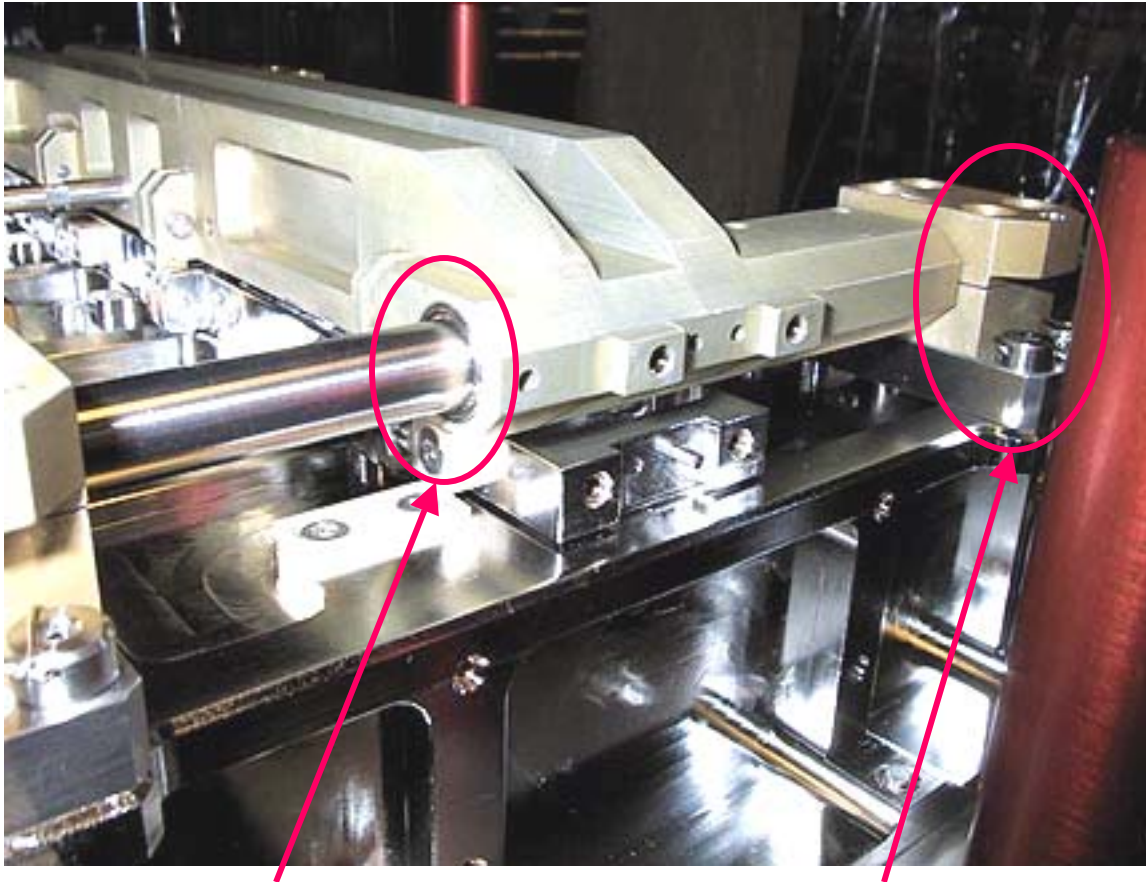
COS FUV Detector Door Rail System

Carriage bearing

Rail post and split clamps

The door rails are mounted on four posts. Two fixed & two moving to accommodate expansion. It was found on both systems that the moving posts were sticking, allowing misalignment of the rails and increased friction (~75% of the redundant actuator force for the rails alone). Essentially the door is over-constrained, and does not allow the moving posts to slide freely in their oversize holes with shoulder bolts.

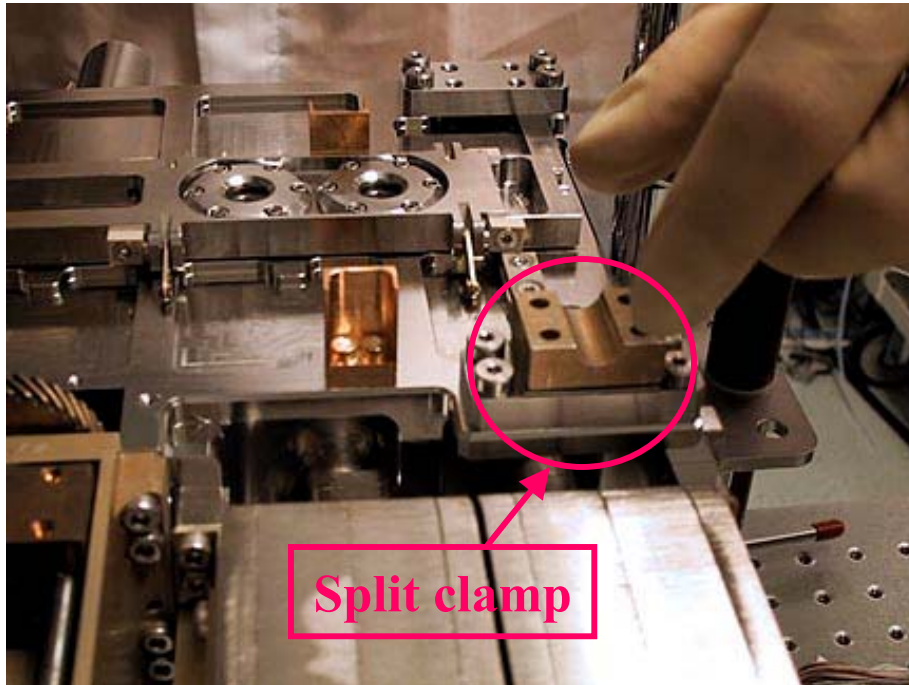
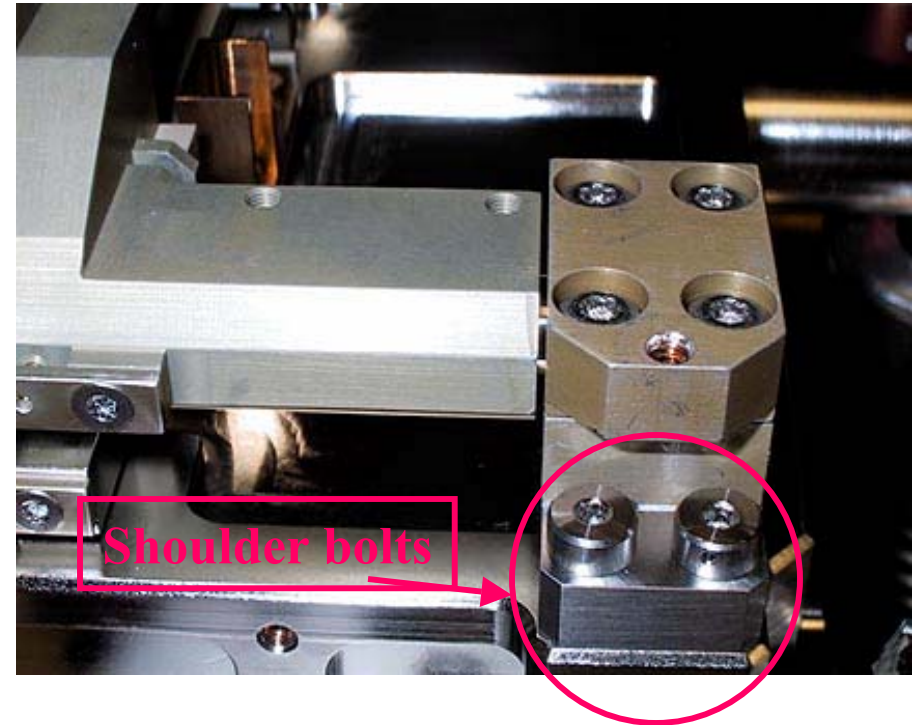
COS FUV Detector Door Rail and Pillar Mounts

A number of factors can exacerbate the rail misalignment, baffle mounting stresses on the posts, and axis errors on the split clamp rail bores. Rail misalignment can also affect the backup door HOP mechanism, forcing the push rod to be misaligned and increasing the friction on the PEEK bushings.

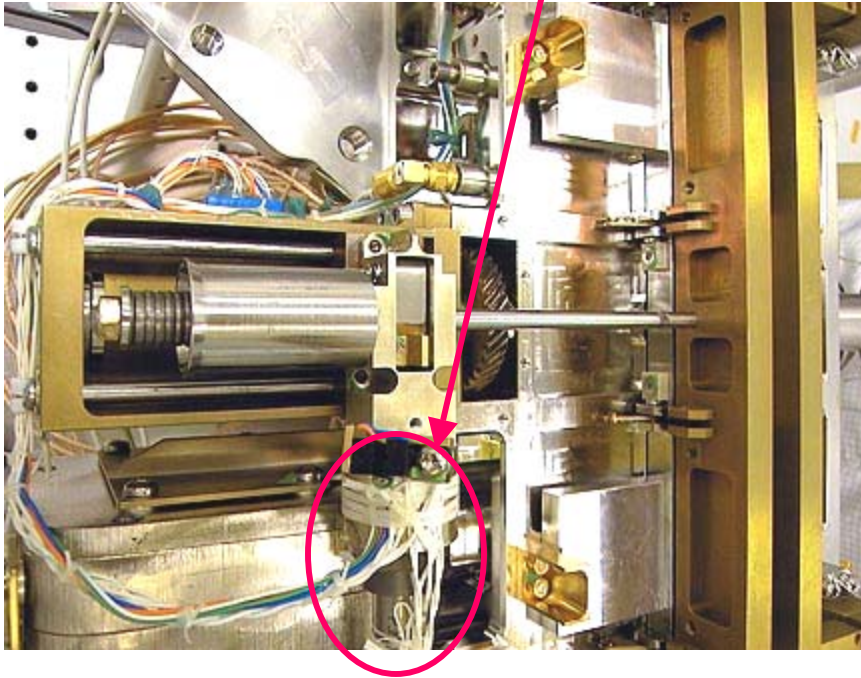
Door push shaft and HOP assembly

The spring packs on FUV01 and FUV02 are both nominal. However, analysis and practice show that the door push shaft is displaced by door carriage misalignment, the friction in the PEEK bushings becomes considerable. The shaft hard mount to the door carriage and the HOP carrier over-constrain it.

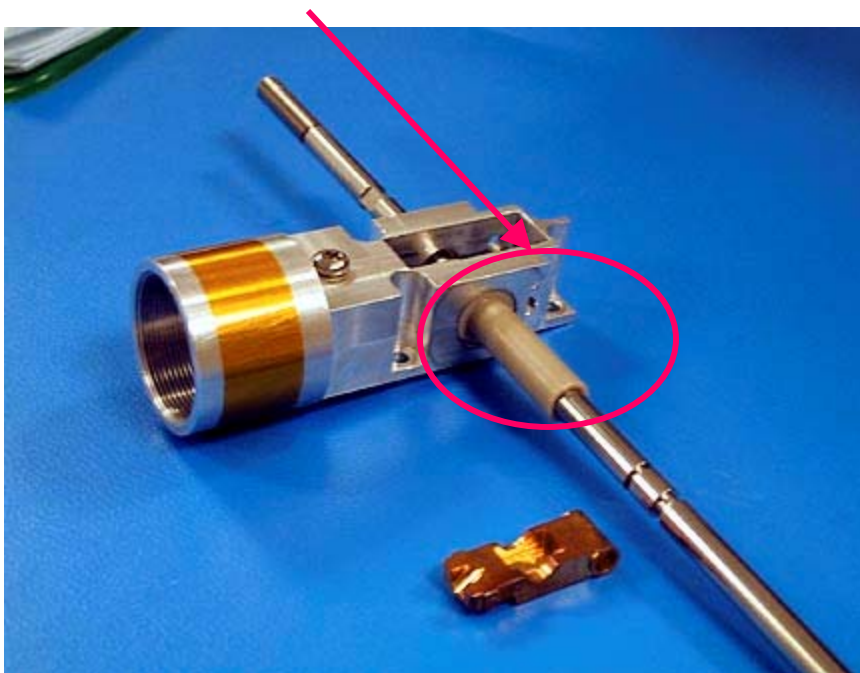
Door push rod actuator housing and PEEK bushings.

The PEEK bushings allow a very small range of angular displacement, and their coefficient of friction is high (0.4)

- Reduce actuator drive shaft diameter to allow flexure, and grease shaft.
 - Replace actuator PEEK bushings with PEEK/PTFE (friction 0.15) and counterbore to reduce friction and reduce angular constraint.

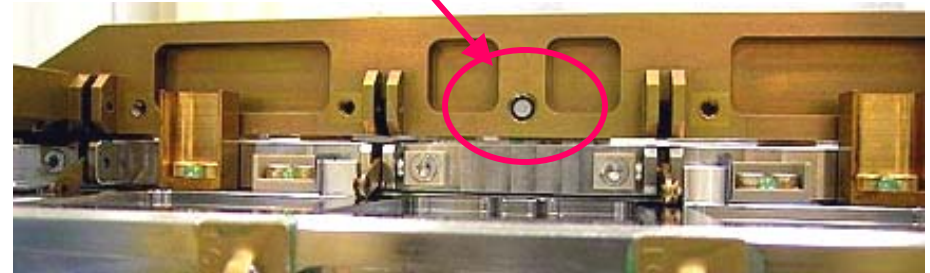
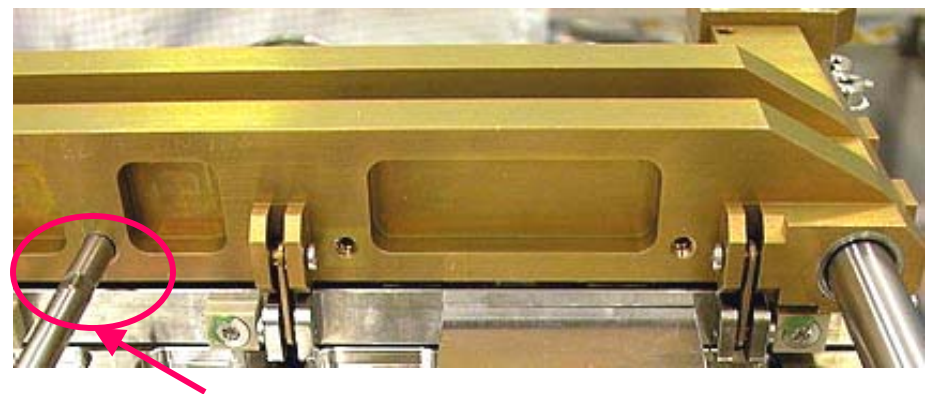
Door push rod screw thread on door far-side

Door push rod on door near-side. The shaft-door attachment has no compensation for rotation or translation

- Grease the rails with Braycote 602 to lower friction .
 - Hard mount all rail pillars and use bored rail holes instead of half clamps.
 - Change link for actuator drive shaft to monoball joint on farside of door carriage.
