COS
Monthly Status Review

February 27, 2002

FUV Door Redundant Mechanism Problem - Design Changes Summary

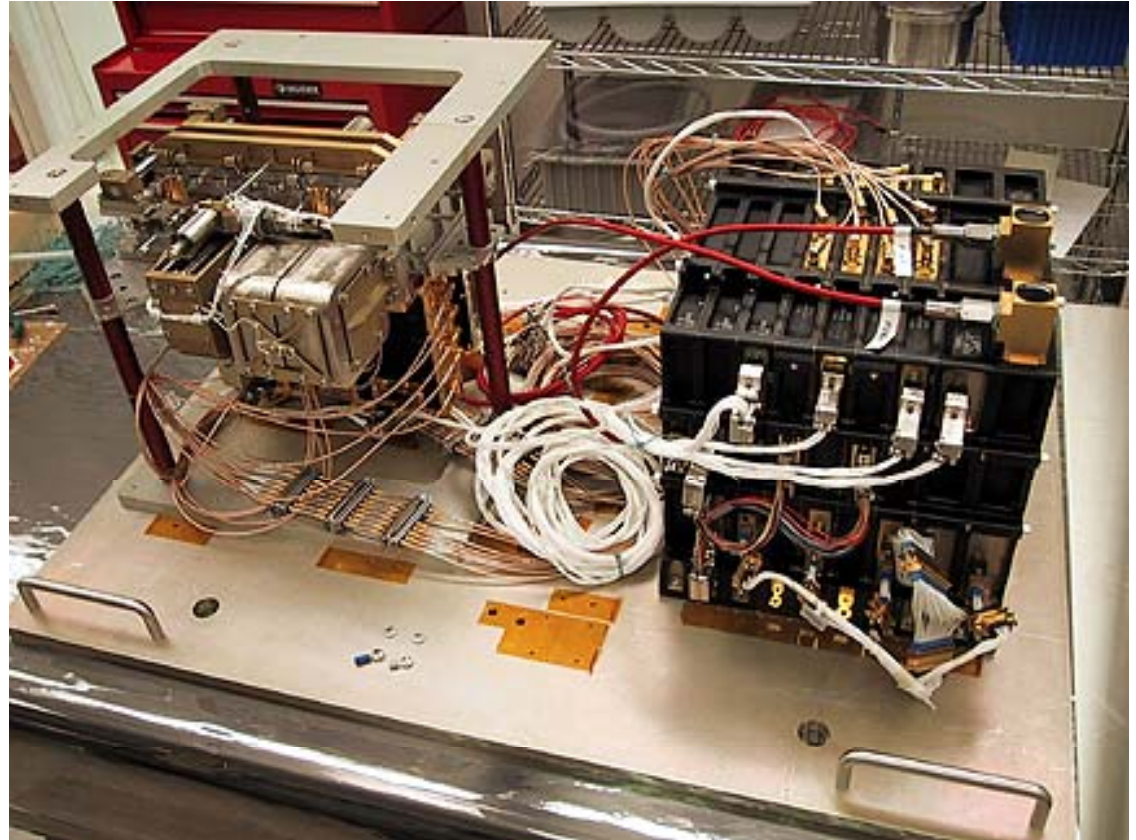
Flight FUV01 Detector System

Detector upper door & mechanism re-worked at UCB.

Door reassembled and tested successfully at CU then vibrated at Ball.

Had door problem in CU vacuum tank post-vibration due to clamshell /shaft tolerancing.

Door motor and HOP subassy at UCB being reworked in collaboration with Swales, CU & GSFC

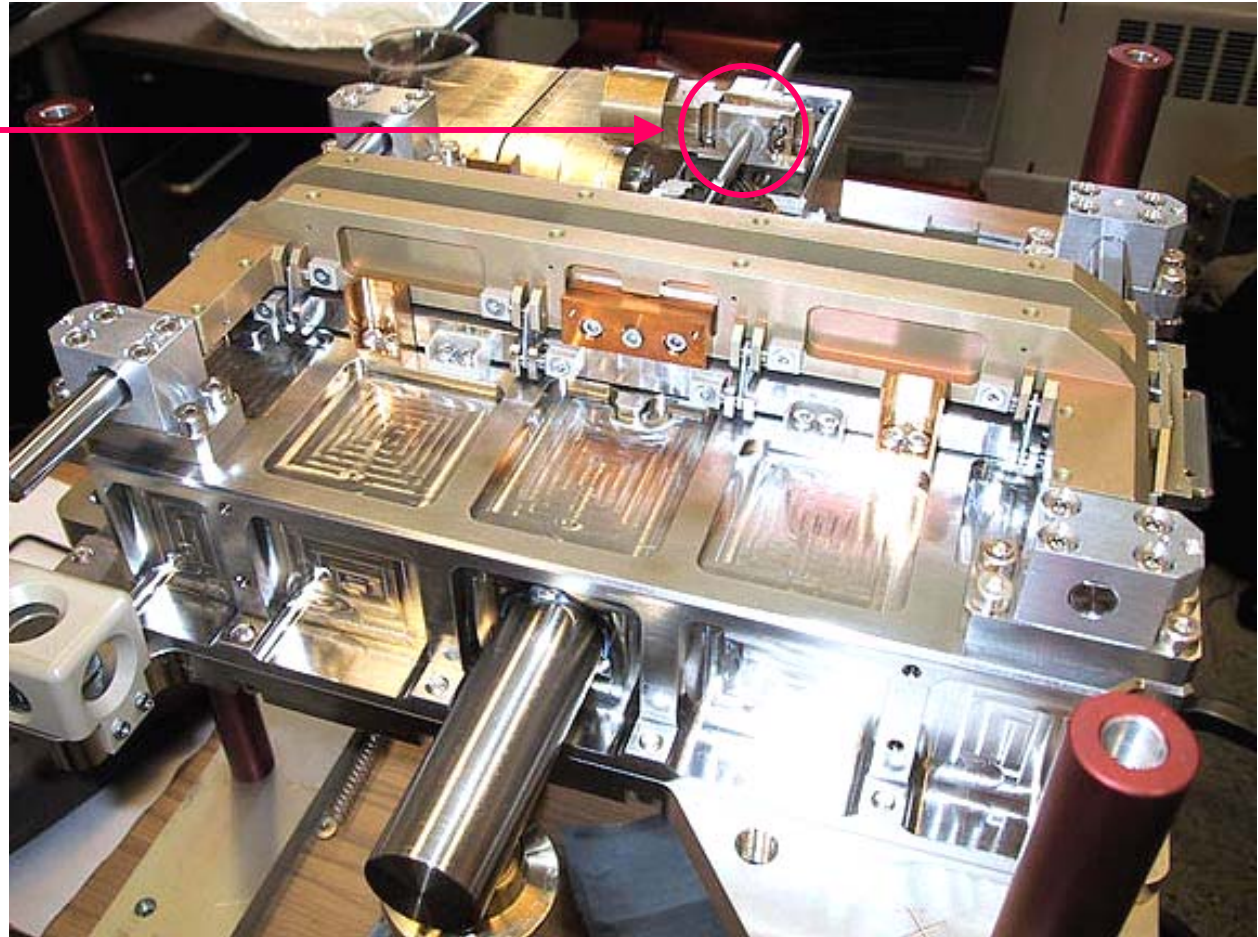
FUV Door - New Assembly on ETU VHA

Problem area,
clamshells &
shaft slots.

Reworked, and
now through
most tests.

All other new
door components
have worked
very well.

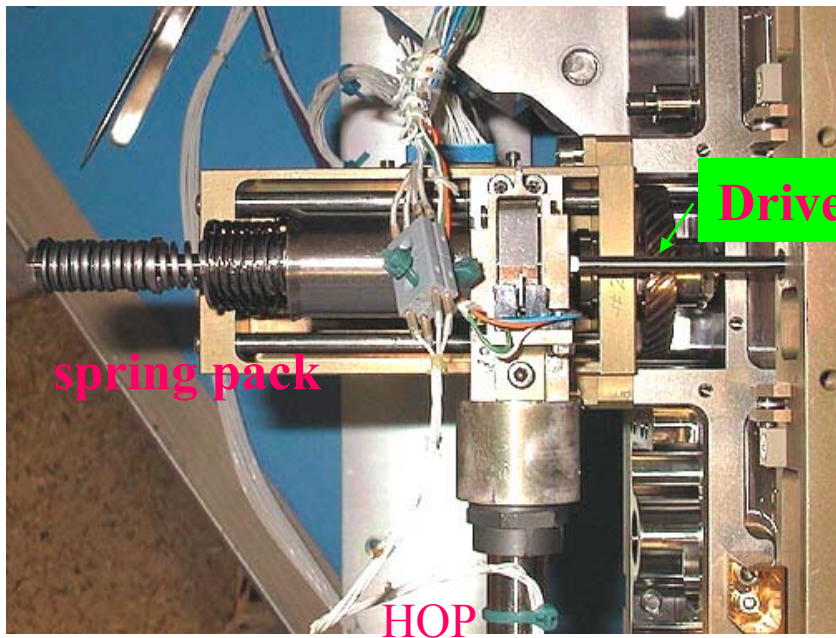
HOP carrier and shaft/spring pack

- Tried to re-engage door with motor after HOP firing - **NO LATCH INDICATION**
- Noticed top clamshell was not engaging the driveshaft & flag not depressed
- Assessment was clamshell/pushrod/housing tolerancing issue
- Produced list of recommendations that have since been implemented

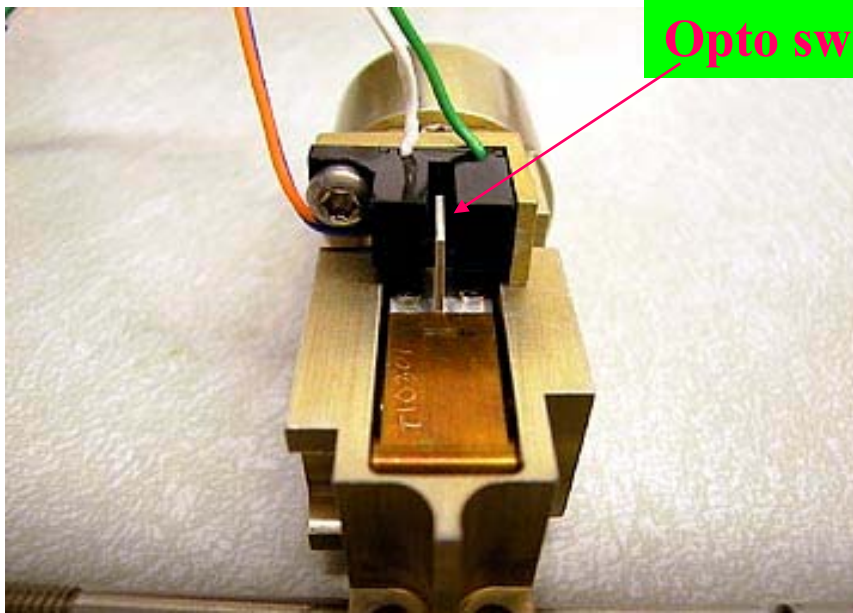
Flag configuration after change

- FUV01 clamshell flag/opto switch clearance increased
 - Flag thinned from 1.5mm to 0.5mm
 - More tolerance for flag rotation and side to side movement of clamshells

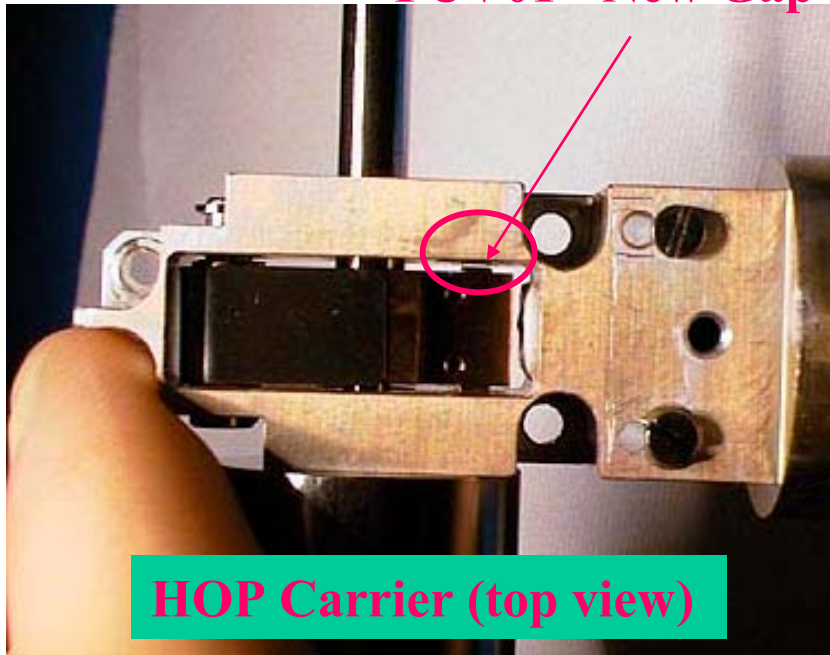
FUV01 - New Gap

- FUV01 clamshell/housing spacing was too tight (0.002")
- ETU clamshells have ~0.006" gap,
- FUV01 clamshells remade - **narrowed the clamshells by 0.010"**
- FUV01 clamshells now have adequate tolerances, - **no friction problems**

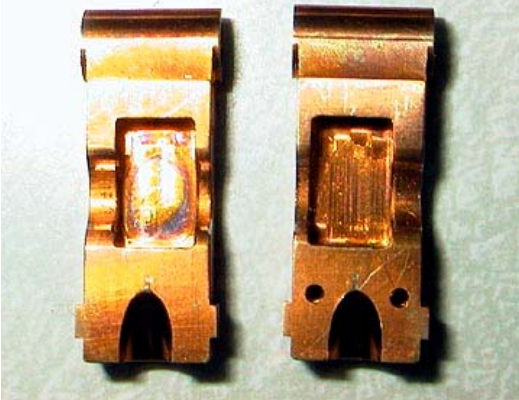
New clamshells and shaft slots

- FUV01 clamshells had about 0.001" slop inside the pushrod shaft notches
- This is too tight - **opened out notches by 0.020"**.
- Modified the clamshell teeth to ensure engagement on the large teeth surfaces.

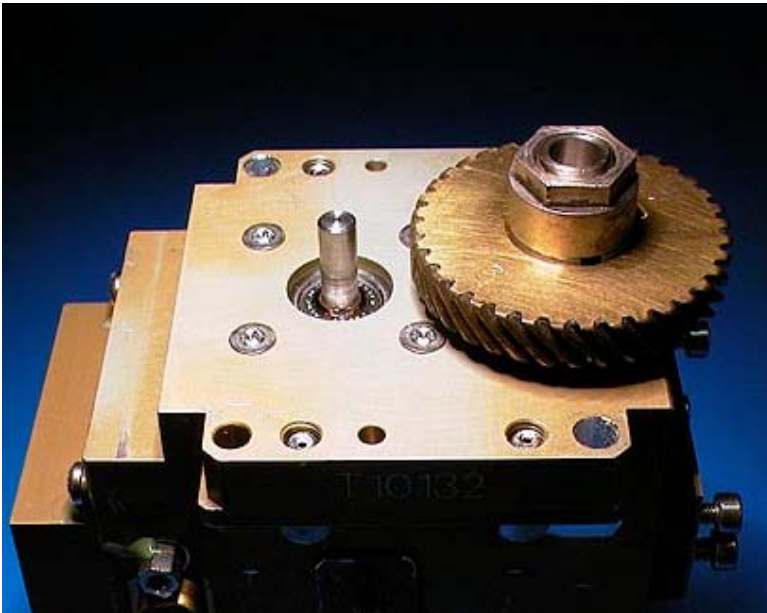
Before Rework

- Driveshaft on motor cog showed signs of slippage/chafing/debris.
- Made tool to ensure correct torque on Trantorque installation - 125in/lb
- Rebuilt FUV01 motor with new shaft and bearing
- Installed wire locks on shaft nuts

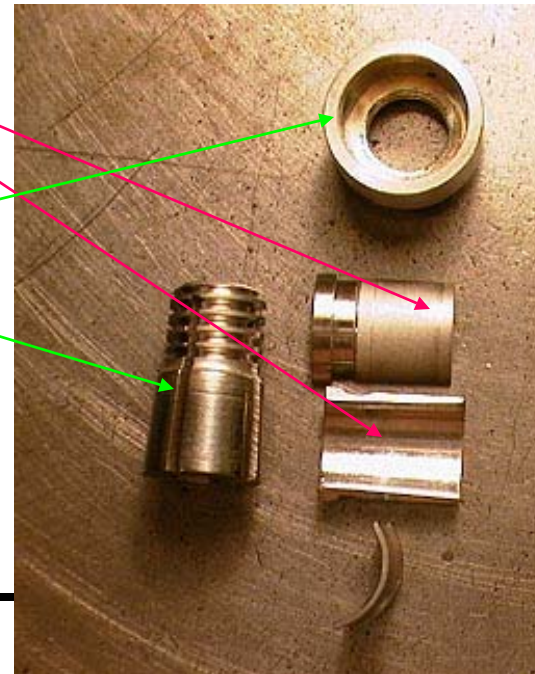
•Trantorque adaptor

- Checked slip limit for motor cogs/shafts when installed to 125in-lbs
 - 70in-lbs/motor, 170in-lbs/driveshaft,
 - both sufficient per Casey's model

•Roughed motor shaft,
 & outside of spreaders and
 polished the inside of spreaders

•Also wired nuts to inner
 sleeves

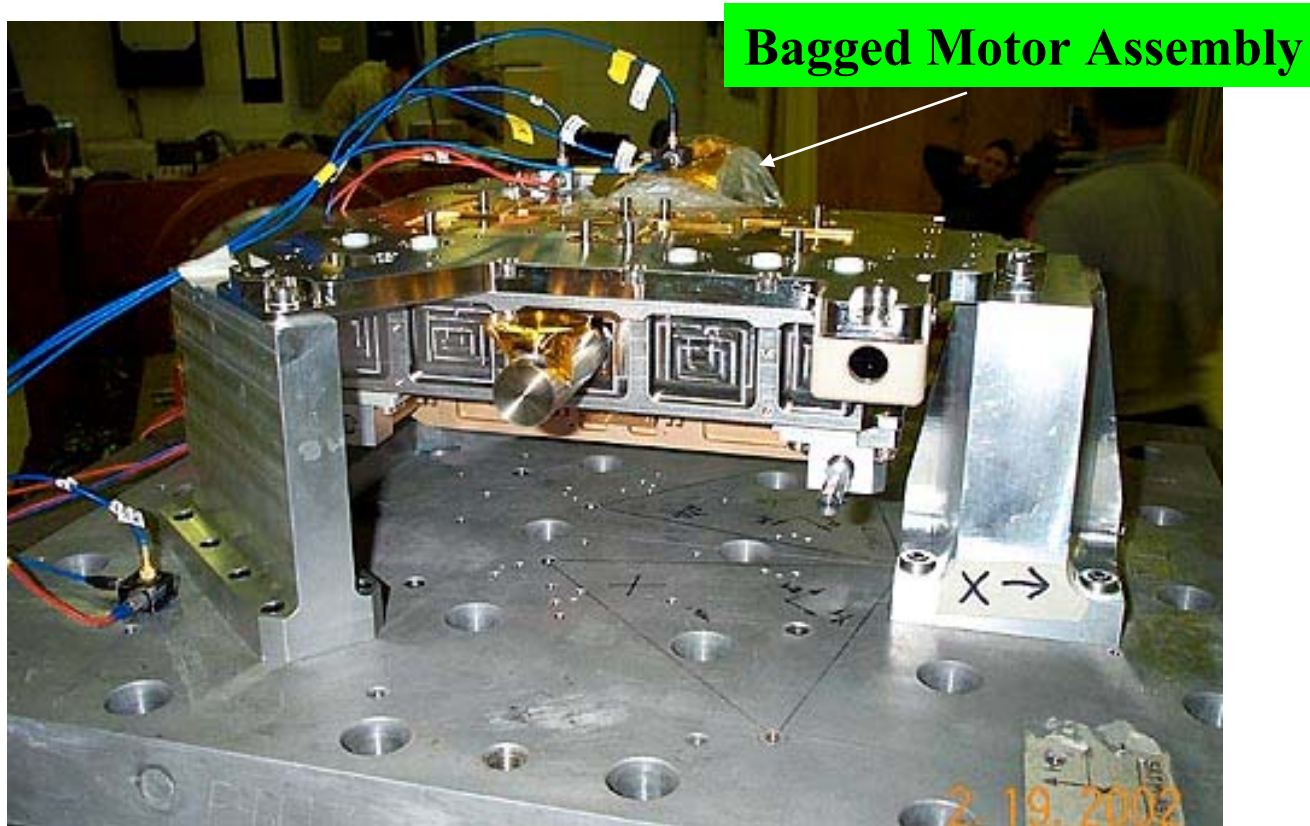
FUV Door - Motor Subassembly Shake on ETU DVA

- **Vibration of FUV01 reworked motor assembly on ETU DVA at Lockheed**
- No ion pumps, no vacuum, qual level to produce correct vibration at motor assy

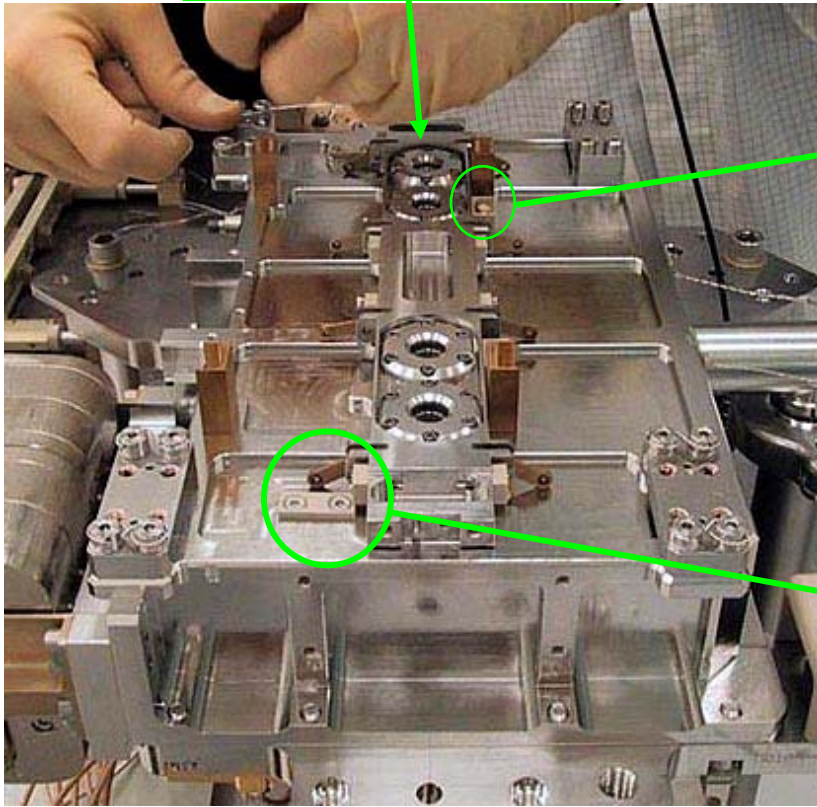
ETU lower door stop -post vibration

- Metal debris found on vibration fixture - does not seem to come from DVA
 - Lower door slid to one side by 1mm
 - door pressure is 100 lb less without vacuum

- Polished steel door seal surface with greased “o” ring – slides,
 - Seal was not broken even with movement, some latitude to move around
 - Door is constrained by blocks and does not lose vacuum integrity
