COS
Monthly Status Review
November 6, 2002
NASA/GSFC

FUV02, VHA Seal Leak, Status

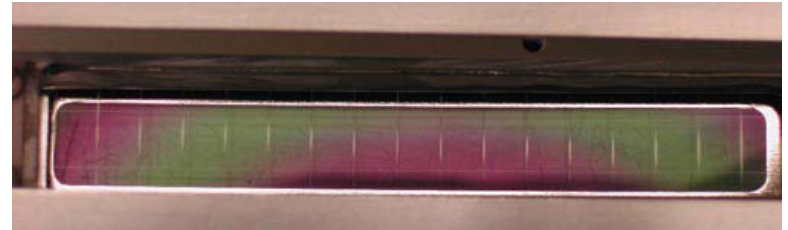
New CsI cathode, A side

New cathode is in accord with the best CsI we have previously done on COS microchannel plates

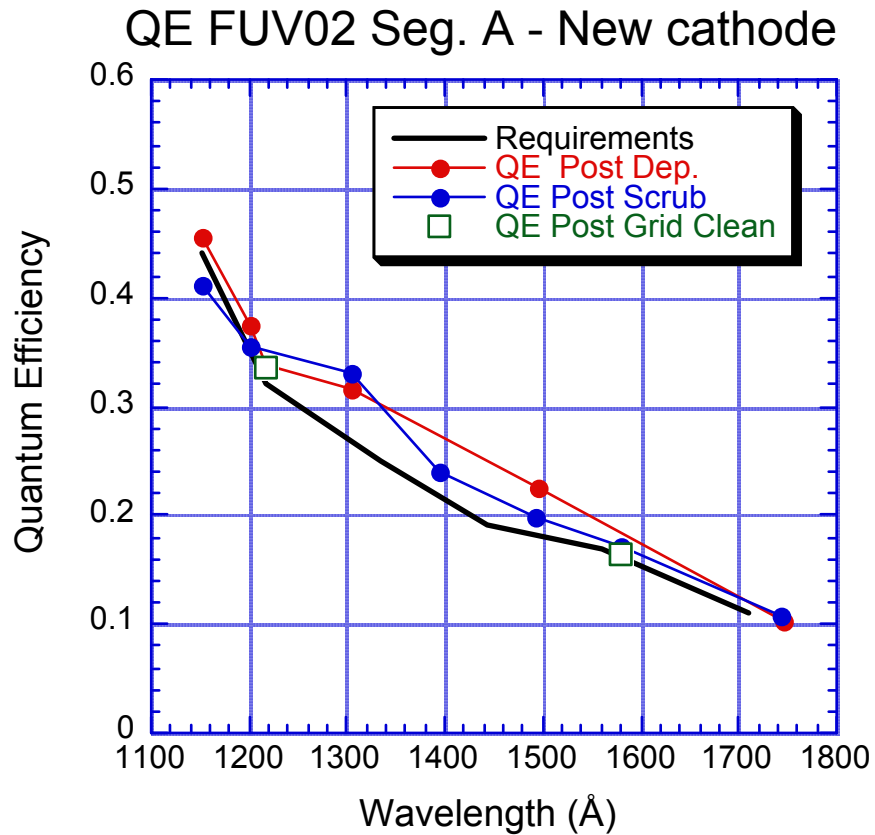
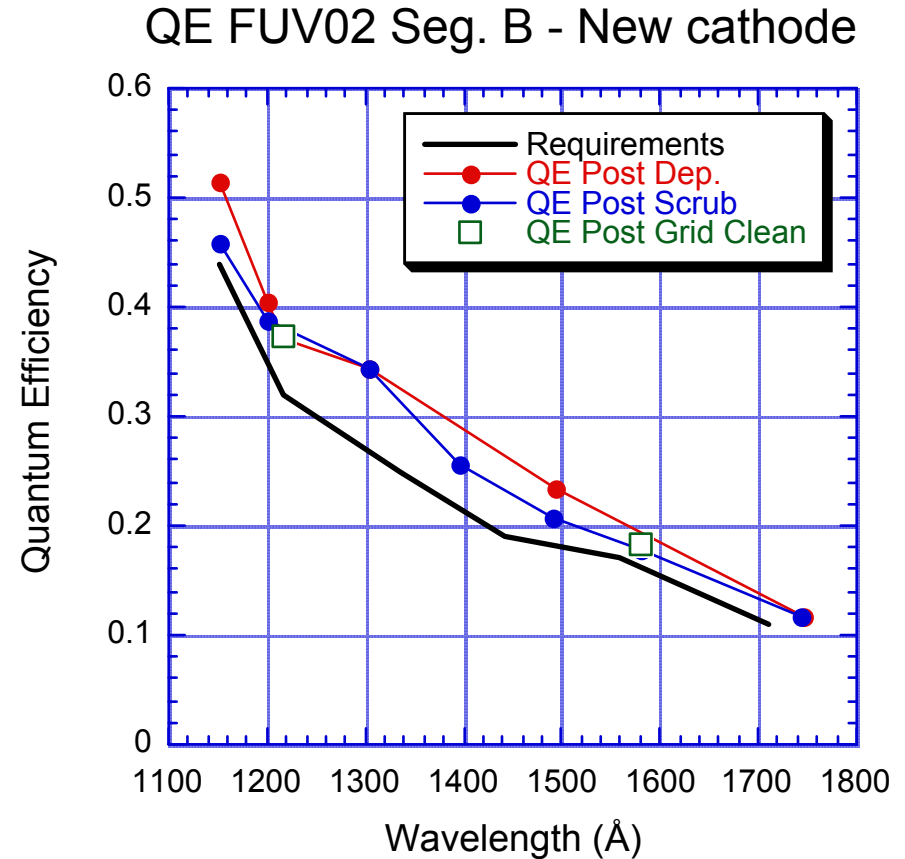
FUV02 New Photocathode QE measurements

QE for FUV02 is ~20% better than FUV01 on average

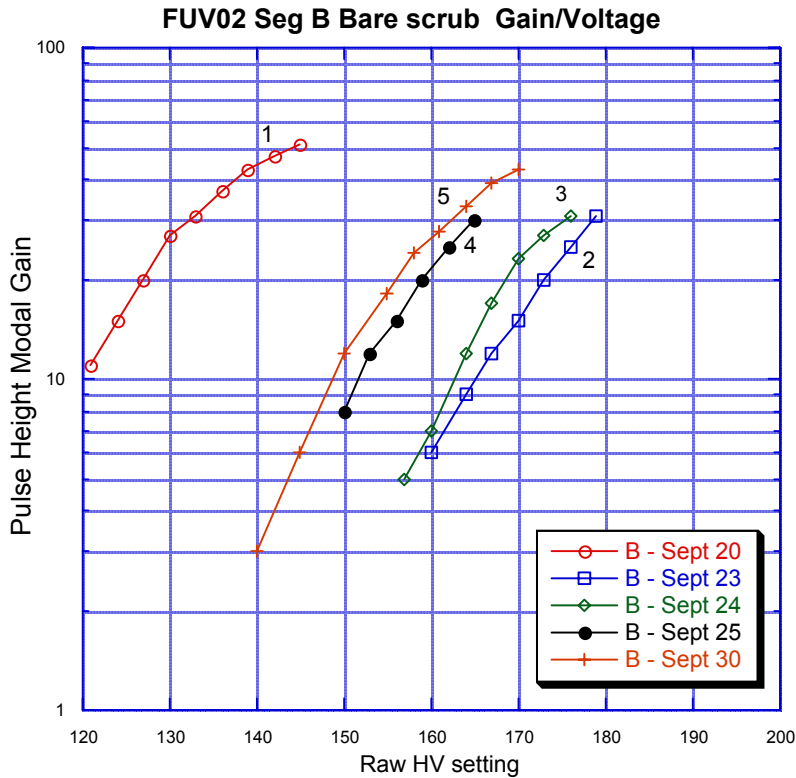
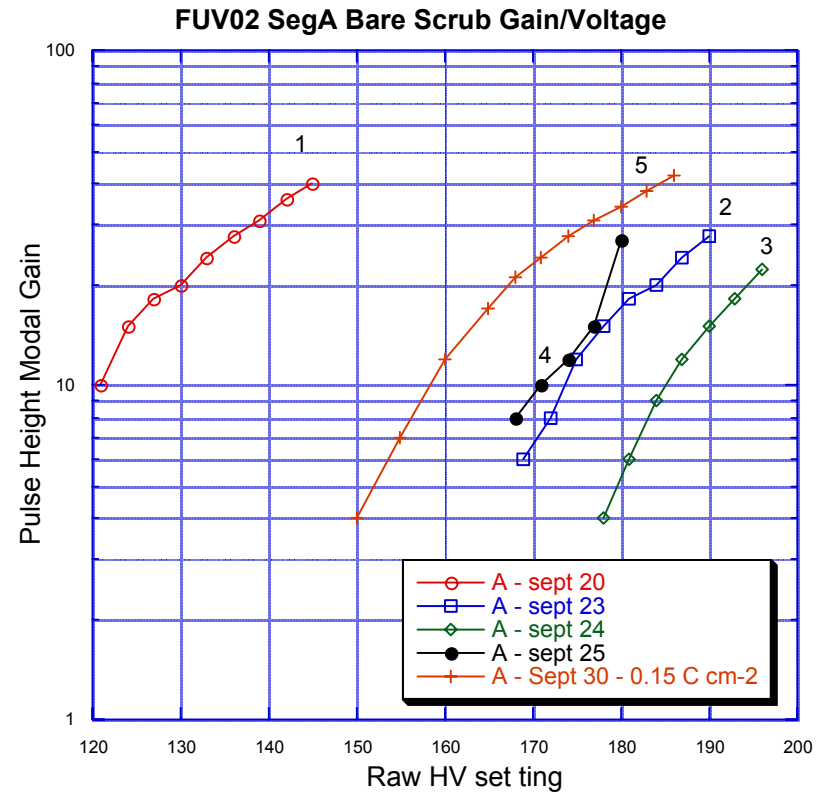
FUV02 Deep Scrub Gain Curve History

Gain decreases due to scrub which is compensated by increasing the MCP voltage
We accomplished the scrub before a cathode deposition to avoid QE degradation!

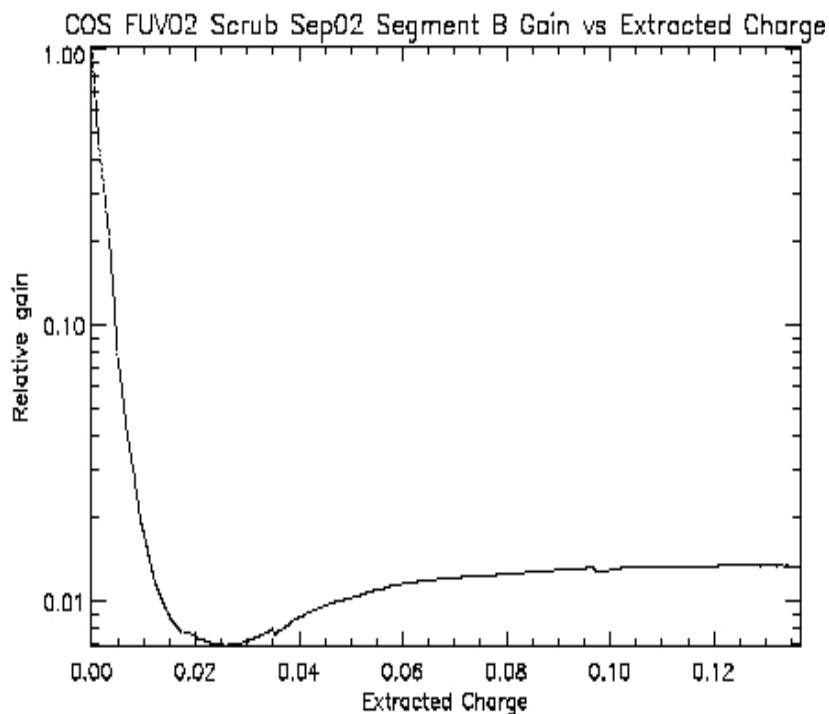
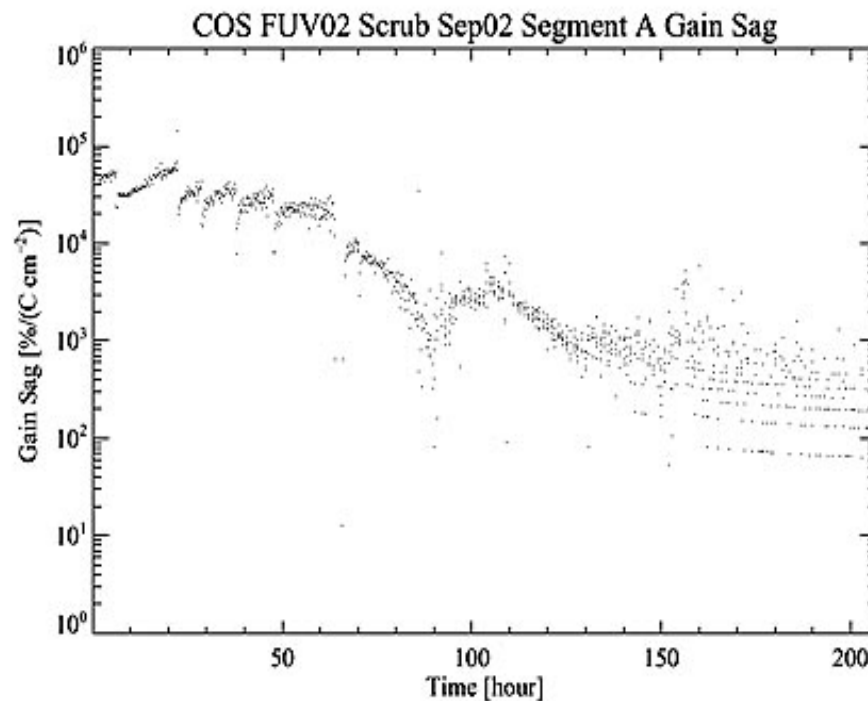
FUV02 Deep Scrub Gain Curve History

The gain decreased as a function of extracted charge then increased and stabilized,
We expect less than x2 gain change per coulomb (COS spec)

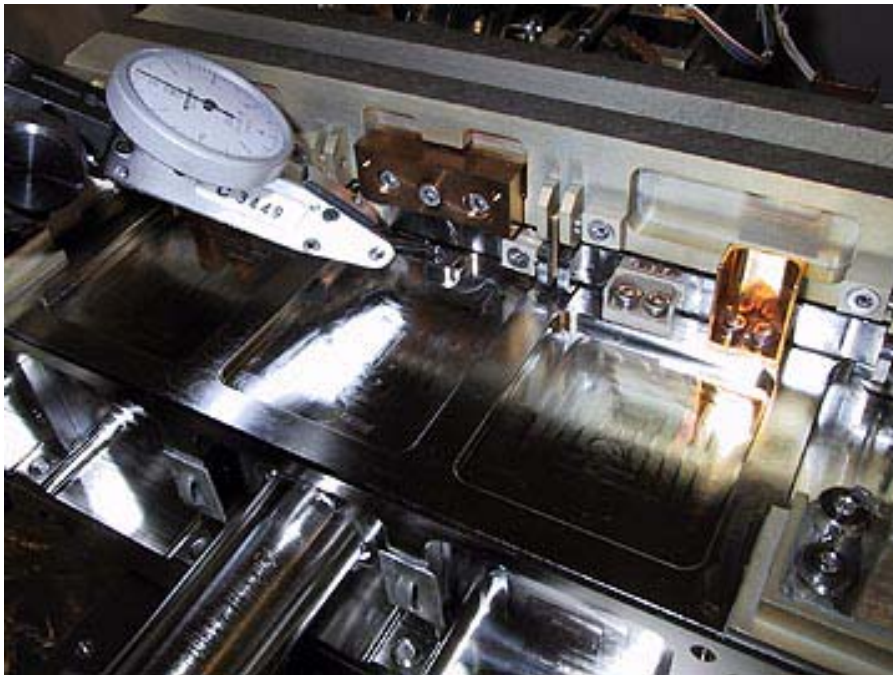
VHA seal area,
compressed "O" ring gap

Door assembly attached to VHA - inspection and metrology

Measurement of VHA surface with
& without atmosphere differential

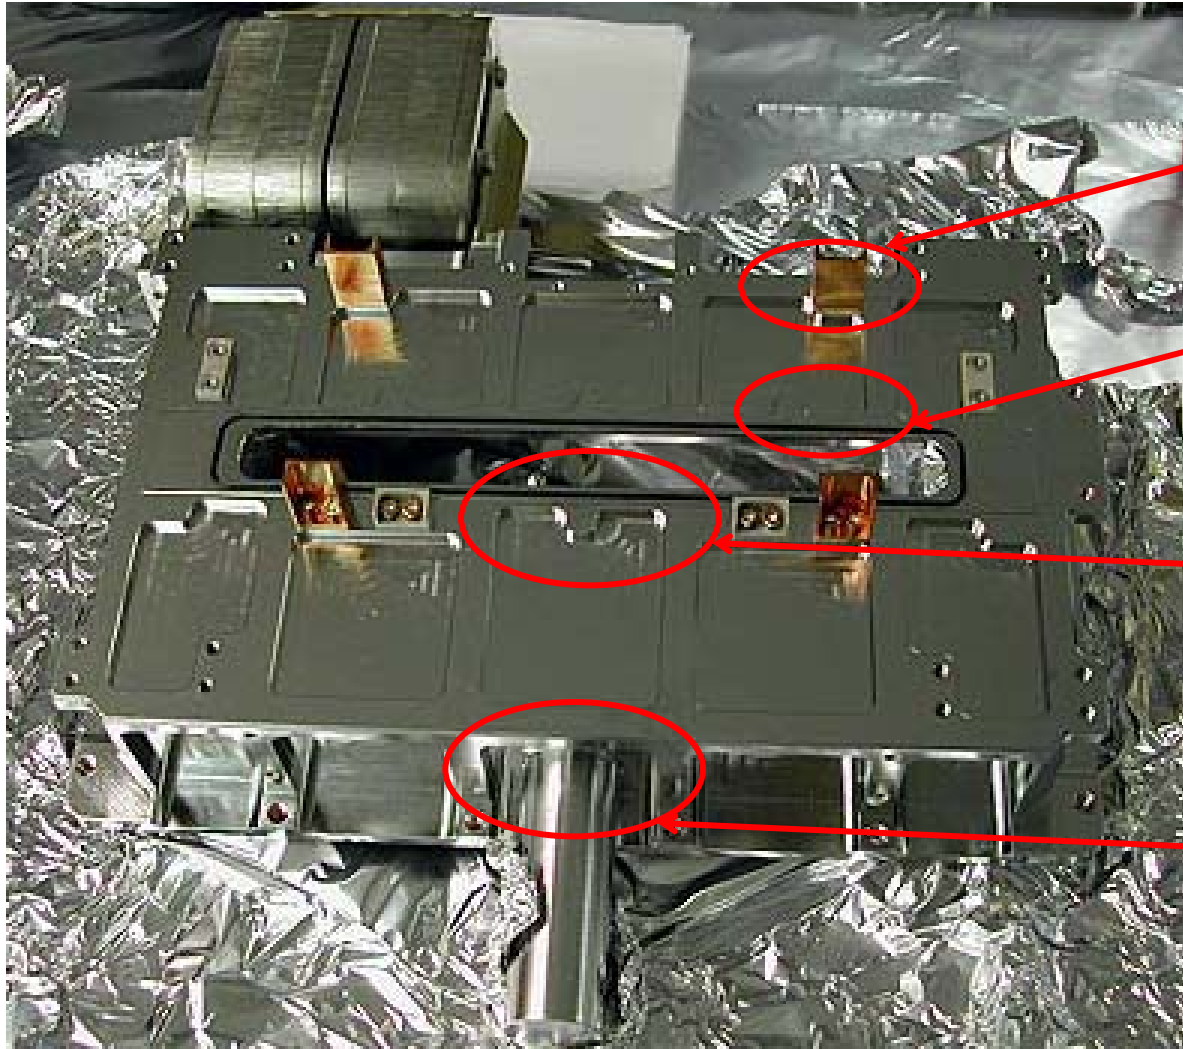
FUV02 VHA with ion pumps

- FUV02 - seal surface shows extra dip of $\sim 0.007''$ at center/port side
 - ETU - seal surface shows extra dip of $\sim 0.003''$ at center/port side

- Also $0.0015''$ dip at SMA connector side for FUV02
- Measurements of FUV02 seal gap
 - At air, $0.008''$ at corners, $0.013''$ at center /port side
 - At vacuum differential, $0.007''$ at corners, $0.014''$ at center /port side

- We have two doors from Ball, FUV01 and FUV02
- Both were measured flat to better than $\sim 0.001''$
- We suspect that the FUV02/ETU VHA distortions were incurred when the pumping ports and SMA feedthroughs were welded in.
- After “o”ring regrease the VHA now seals and there is no leak
- **Door/VHA has accumulated >40 successful operations,**
 - **There is probably a re-distribution of grease on the “o” ring with ops**
 - **Leak appears only at 1 Atm differential, after many operations**

~0.0015" dip

~0.007" dip

Pumping port weld area

- FUV02 DBA (detector) is currently stored separately under vacuum
- FUV02 VHA is fully assembled and under vacuum with ETU DBA
- We have investigated many different ways of resolving the problem with emphasis on maintaining the FUV02 integrity
- Our preferred resolution involves re-surfacing of the seal door to match the VHA shape

- Metrology gives us a detailed measure of the shape of the seal surface
- Remove FUV02 seal door and substitute ETU to maintain vacuum
- Make door blanks and resurface them using EDM + polish
- Check the measurements & seal with blanks + FUV02 VHA
- Resurface the FUV02 seal door using EDM + polish
- Re-install the FUV02 seal door and re-shim the door mechanism to achieve the correct seal gap, and measure with Atm differential
- Run door operation tests and re-verify seal and metrology
- Re-install detector/DBA and continue with FUV02 completion plan
- This minimizes disassembly of VHA (none on DBA) and risk to assy
- Achieves desired uniform seal gap/"o"ring compression
- Minimizes time & cost to effect the resolution
- Also obtain "profiled" "O" rings to "accommodate" gap (backup)
- Make spare door to accommodate AU options
