COS
Monthly Status Review
December 10, 2002
Ball

COS
Monthly Status Review

FUV02, VHA Seal Leak, Status

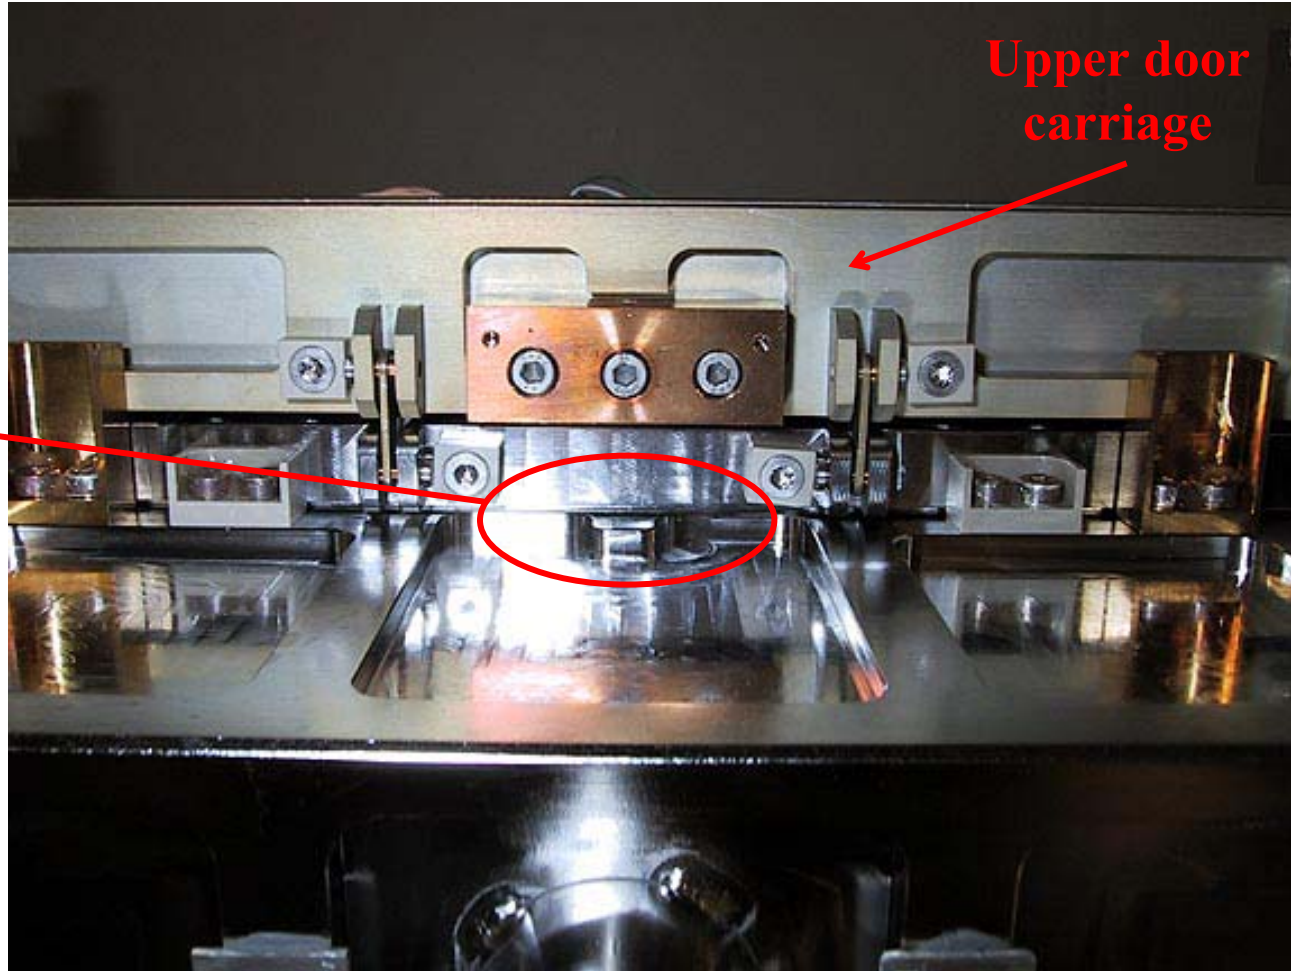
Door assembly attached to VHA

Area where
leak occurred

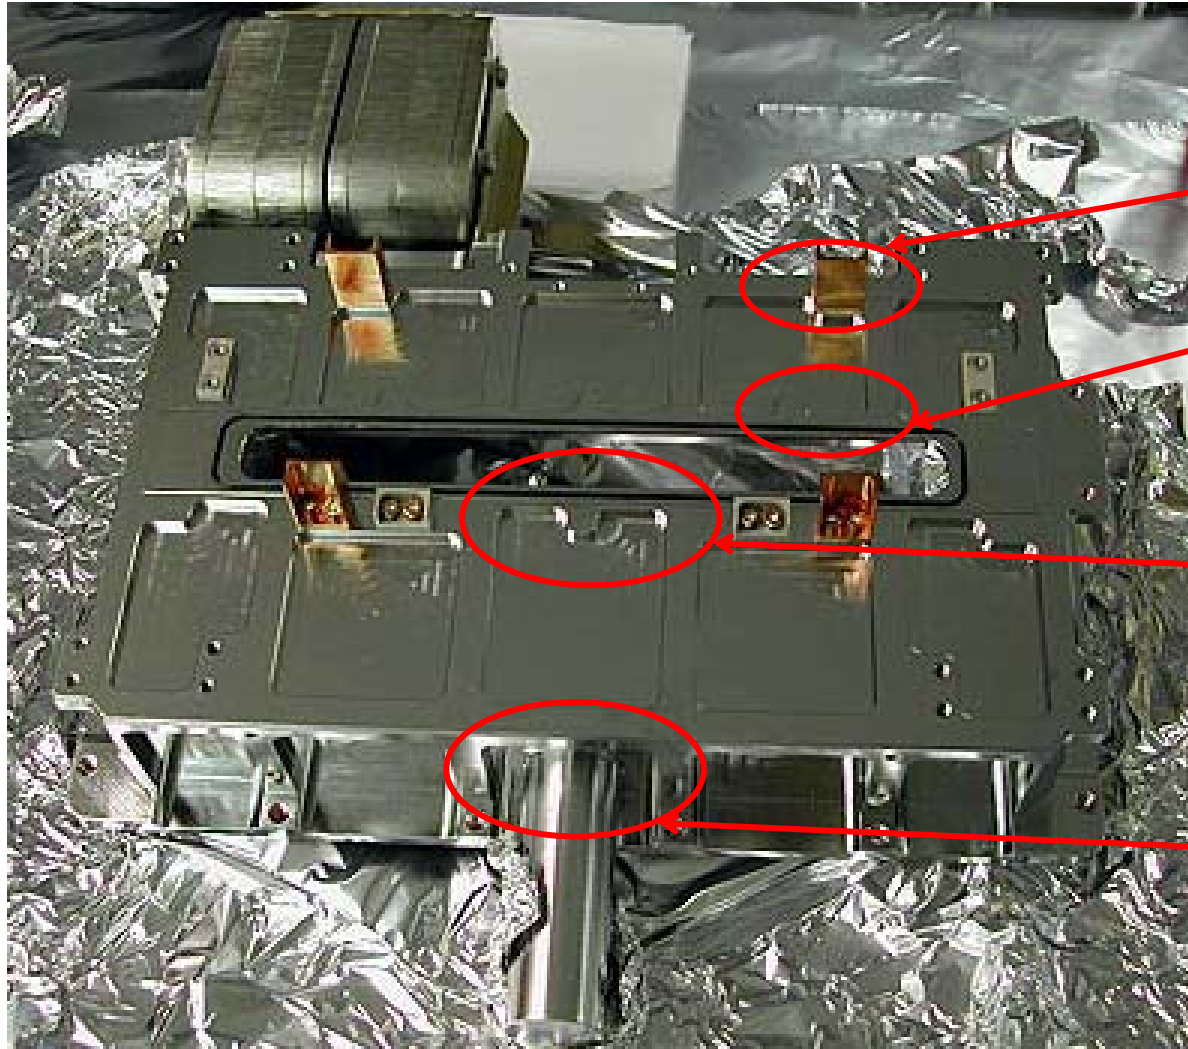
FUV02 VHA with ion pumps, showing metrology

~0.0015" dip

~0.007" dip

Pumping port weld area

- FUV02 - seal surface shows extra dip of $\sim 0.007''$ at center/port side
 - ETU - seal surface shows extra dip of $\sim 0.003''$ at center/port side

- Spare - seal surface is flat to $0.001''$
- FUV01, FUV02, & ETU all have SMA connectors and pump ports welded on. Spare has not been welded.
- FUV02 also shows small dip $0.0015''$ dip at SMA connector side

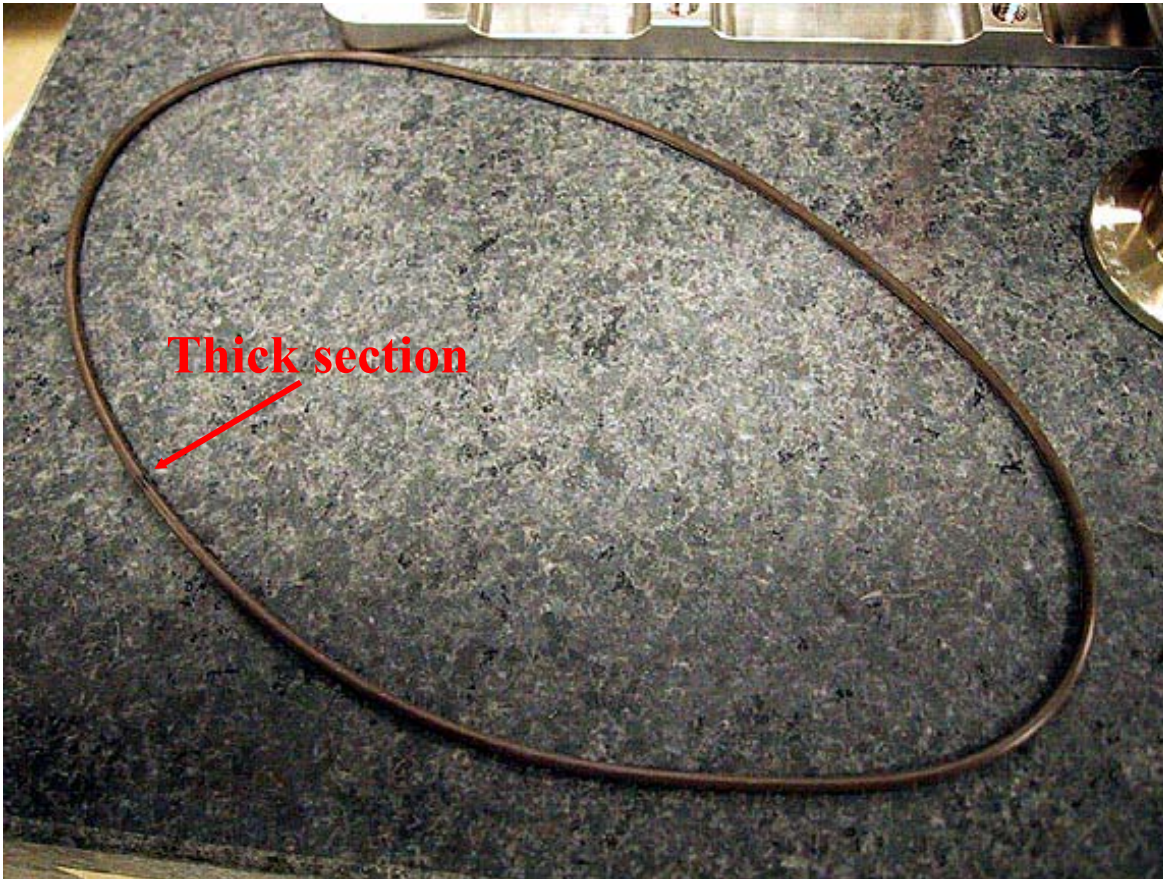
FUV02, New "O" ring design

IER, custom, viton.
0.070" diam, with
0.077" section in one
axis graded over 7"

Parker 2-050,
Standard, viton

- Proceeded with “o” ring replacement
 - Metrology gives detailed measure of shape of the seal surface & gaps
 - Removed FUV02 “O” ring seal and substituted new “O” ring
 - Checked the gap measurements & tested the vacuum seal - OK
 - Ran door operation tests (40 cycles) re-verifying seal and metrology
 - Did Qual level shake test with FUV02 DVA and ETU DBA at AMES
 - Under vacuum with ion pump pressure monitored
 - Showed no anomalies compared to expected behavior
 - Checked the gap measurements & tested the vacuum seal - OK
 - Re-installed detector/DBA and continued with FUV02 completion plan
 - This minimized disassembly of VHA (none on DBA) and risk to assy
 - Door did not need reshimming, door was only removed/reinsalled
 - Achieves desired uniform seal “o”ring compression

- Result - greater “o ring” compression & better seal with new “o ring”

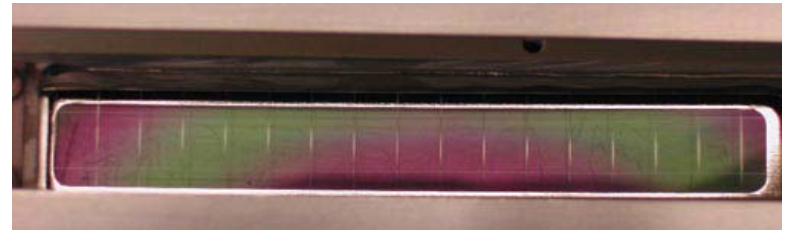
New CsI cathode, A side

New cathode is in accord with the best CsI we have previously done on COS microchannel plates
