Follow-up Report on Possible Contamination of the COS Grating Test Facility from Klinger Stages

Date:	January 19, 2001
Document Number:	COS-03-0005
Revision:	Initial Release
Contract No.:	NAS5-98043
CDRL No.:

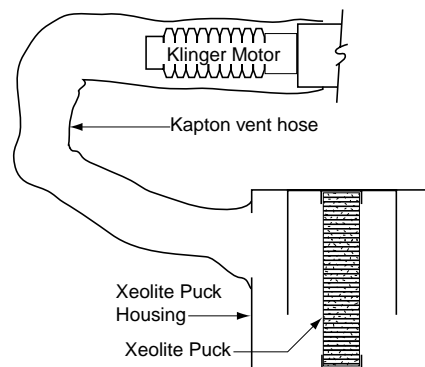
Figure 1. Venting for Klinger motors. Typically, several motors share a common puck housing.

In order to mitigate any further contamination we took the following steps: We removed all klinger stages from the chamber and cleaned them as far as was practical without fully disassembling them using a variety of solvents (toluene, fluroclean, acetone and IPA), and then reinstalled them in the chamber. We then wrapped all motors in black kapton film, and vented the motors through xeolite pucks obtained for the FUSE projects (fig. 1). In addition to this encapsulation, we have also begun to reduce motor heating by limiting the time that the motors are energized as much as possible. We deenergize the motors after each movement and leave them off until they are needed again.

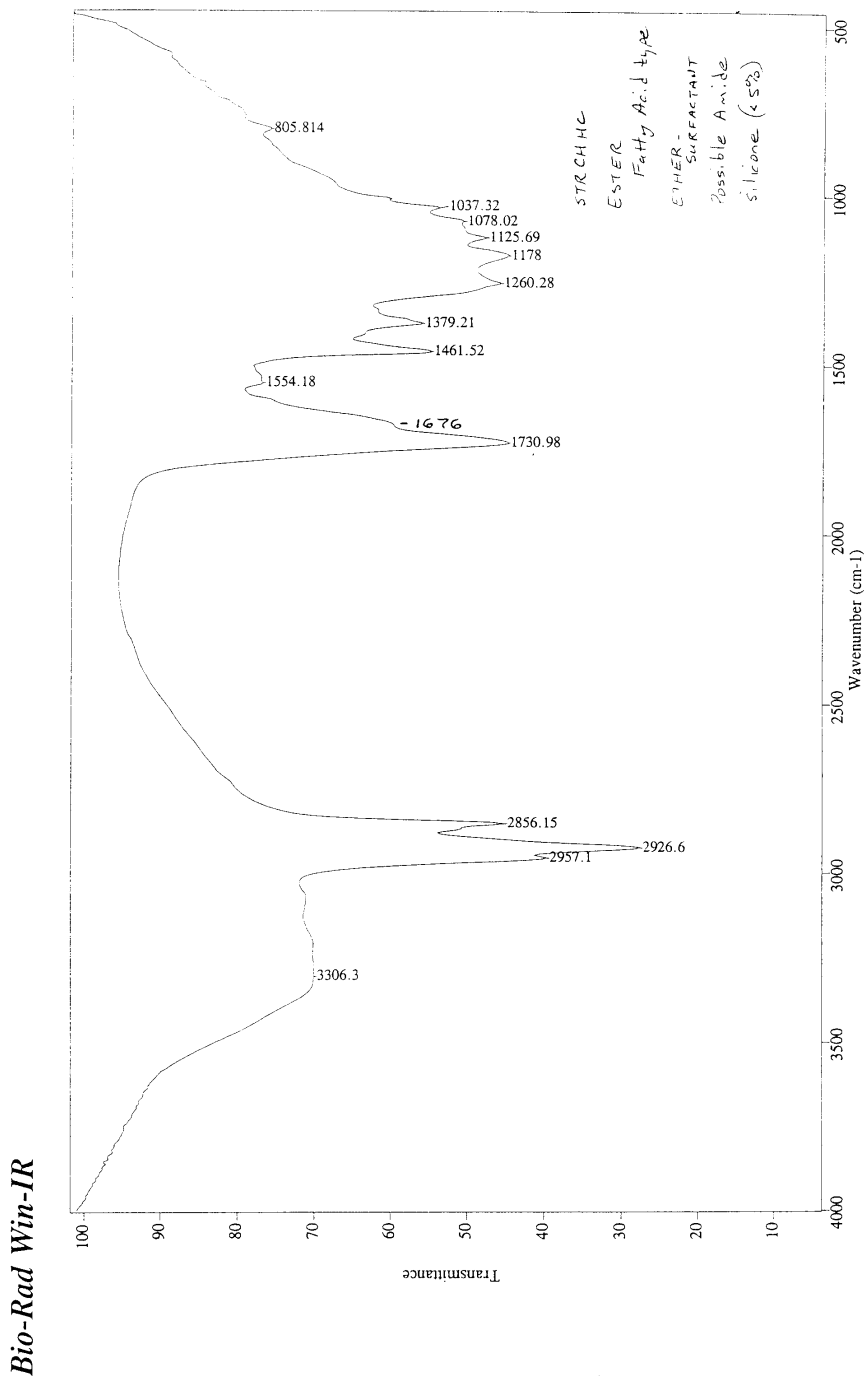
File # 1 : 00-0617

NVR = 0.04 mg/sq. ft. NVR # 00-272

IR # 00-0617 shows the major components of the residue to be: Straight chain hydrocarbons, Esters – fatty acid type, an ether – surfactant, possibly an amide, and a small amount (<5%) of silicone.

Comment: 31076 CASA 12"X12" PLATE 0.04 MG/FT² 4/21/00 DPRR M# T15

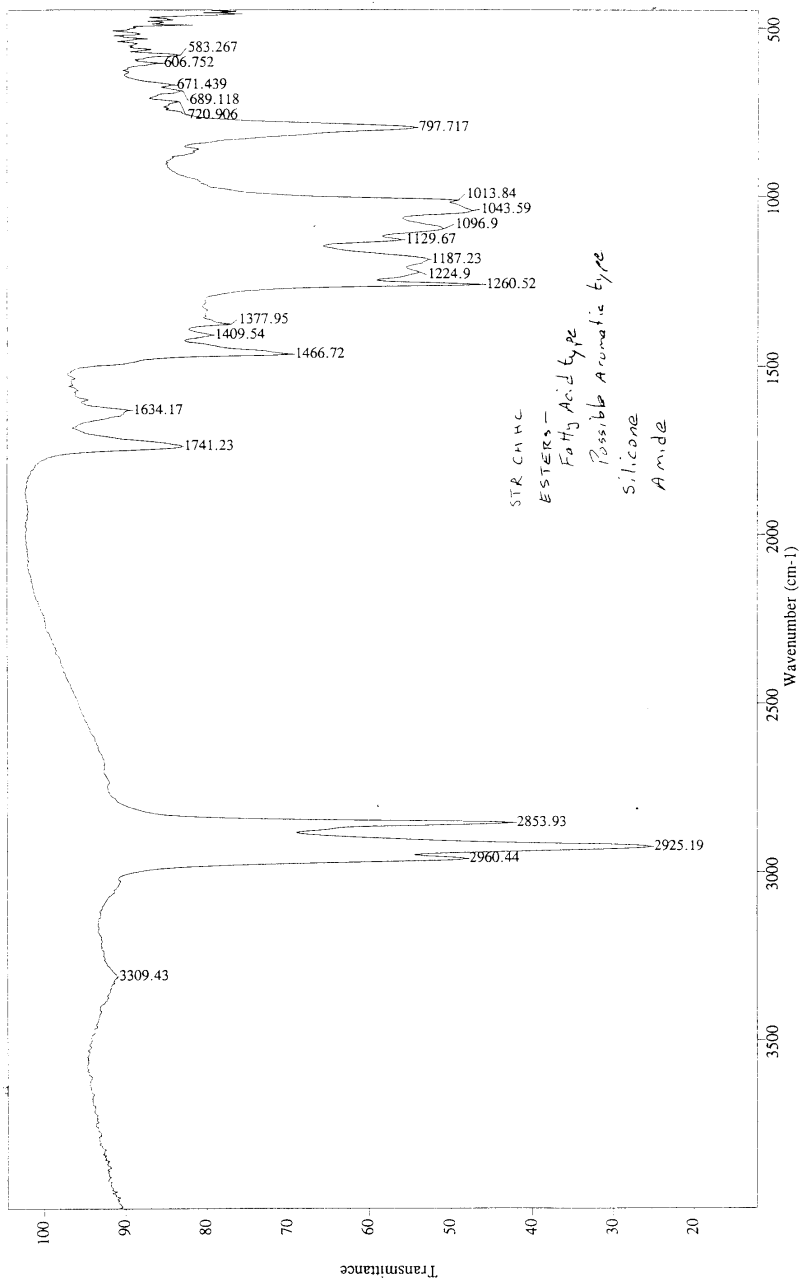
File # 1 : 00-0881

1. URM 100 exterior surface. IR shows the major components of the surface contamination to be: Straight chain hydrocarbons (oil), Esters – fatty acid types and possibly aromatic types, silicone and an amide.
2. MTM 150 interior surface. IR shows the major components of the surface contamination to be: Straight chain hydrocarbons, and esters – fatty acid type and a small amount of aromatic type.

Comment: 31076 CASA URM 100 surface contamination, DPRR 6/8/00, m# FS

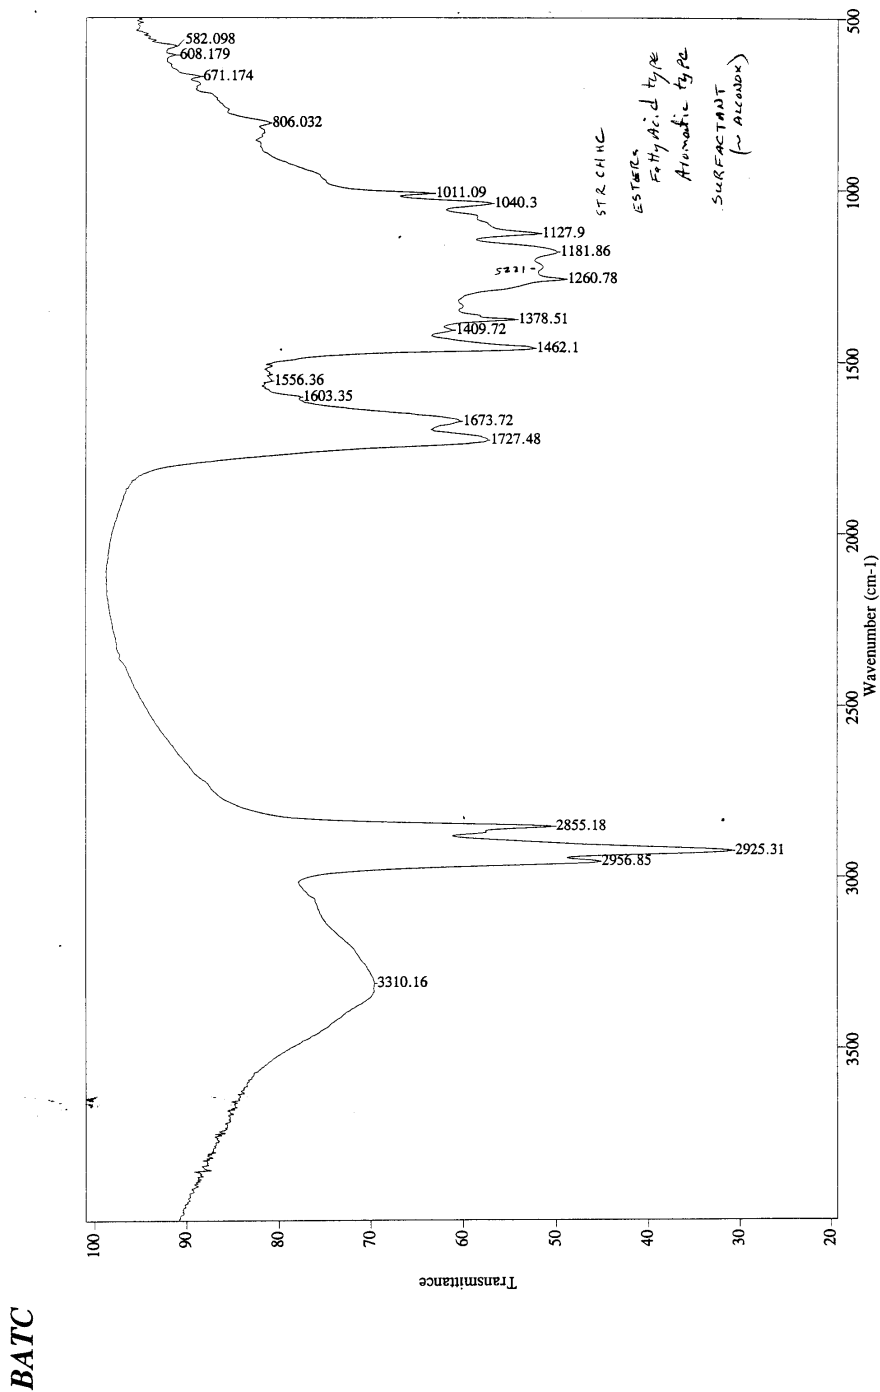
Sample	NVR mg/sq. ft.	NVR # 00-	IR # 00-	IR of residue: Major Components
S.S. Witness plate	0.06	443	0913	Str ch hc*, Esters – fatty acid and aromatic types, Surfactant – similar to Alconox.
Chamber wall N. port	0.10	445	0915M	Polyester – similar to material extracted from TX 609 tissue.
S.S. optical plate	1.37	444	0914	Similar to residue obtained by rinsing Nitrilite gloves with IPA.
Optical table	0.10	446	0916	Str ch hc, Esters – aromatic and fatty acid types, probably a surfactant – similar to Alconox

View Mode: Overlay
 6/19/00 9:14 AM Res=4cm-1
 File # 1 : 00-0913
 Number of Scans: 512
 Comment: 31076 CASA Witness plate "X", DPRR 6/13/00, 0.06 mg/sqft, m# 135

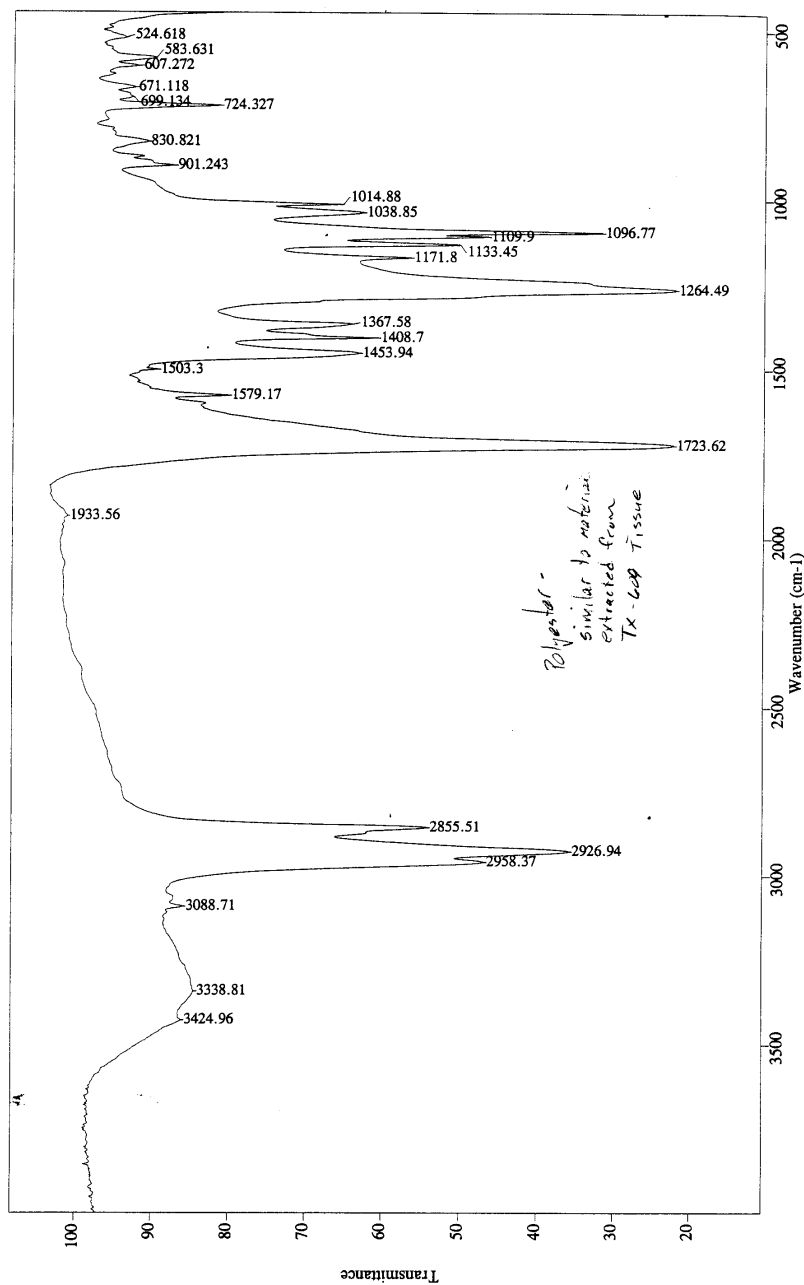
File # 1 : 00-0915M

Comment: 31076 CASA Chamber north wall, 90 sqin DPRR 6/13/00, 0.10 mg/sqft, m# A14

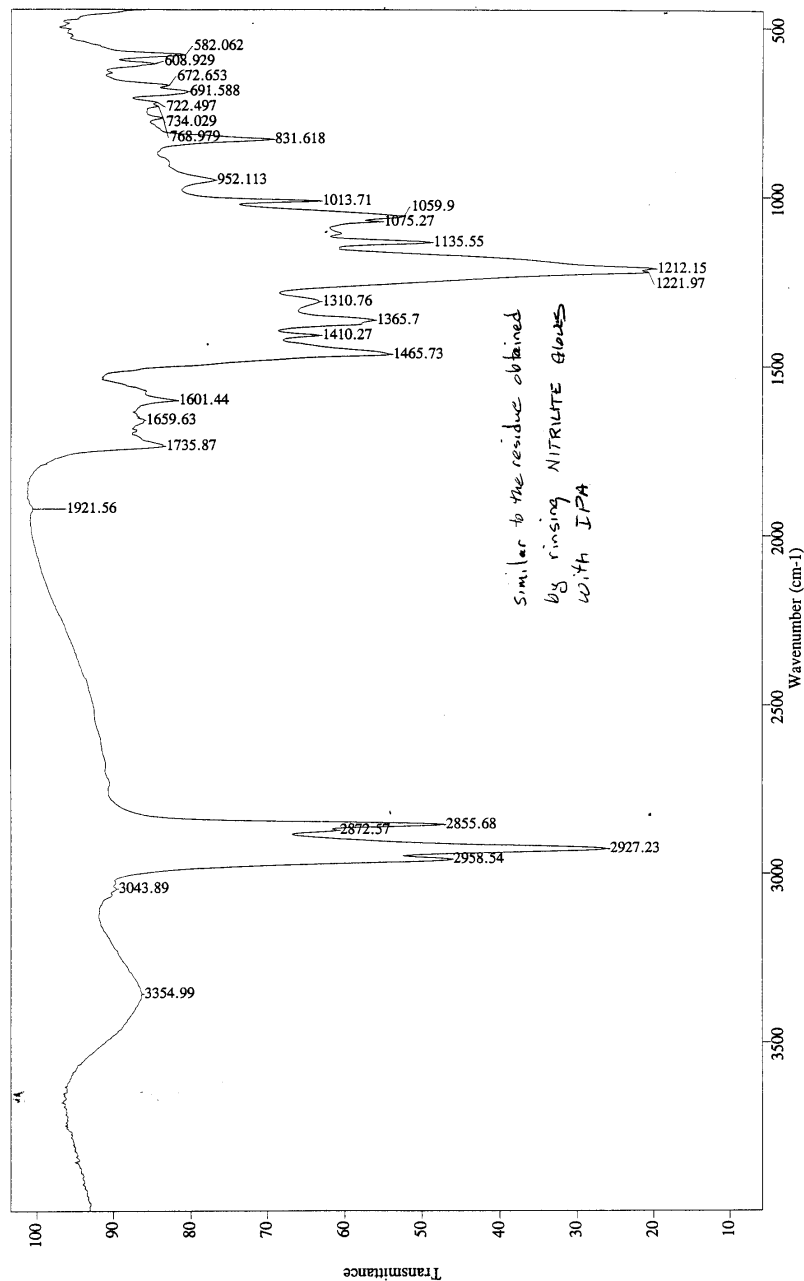
File # 1 : 00-0914

Comment: 31076 CASA SS Optical Plate, DPRR 22 sqin, 6/13/00, 1.37 mg/sqft, mh# 14

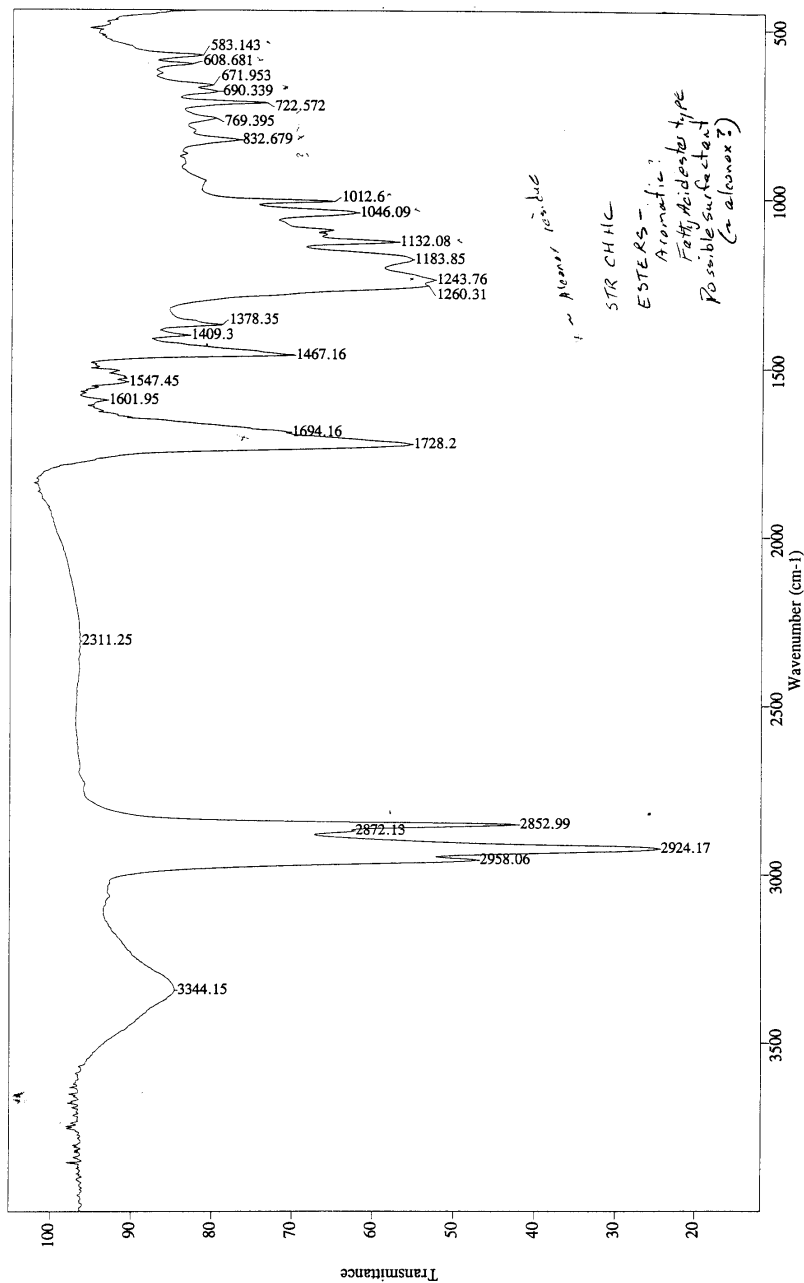
File # 1 : 00-0916

Comment: 31076 CASA Optical table 72 sqin DPRR, 0.10 mg/sqft, m # T29

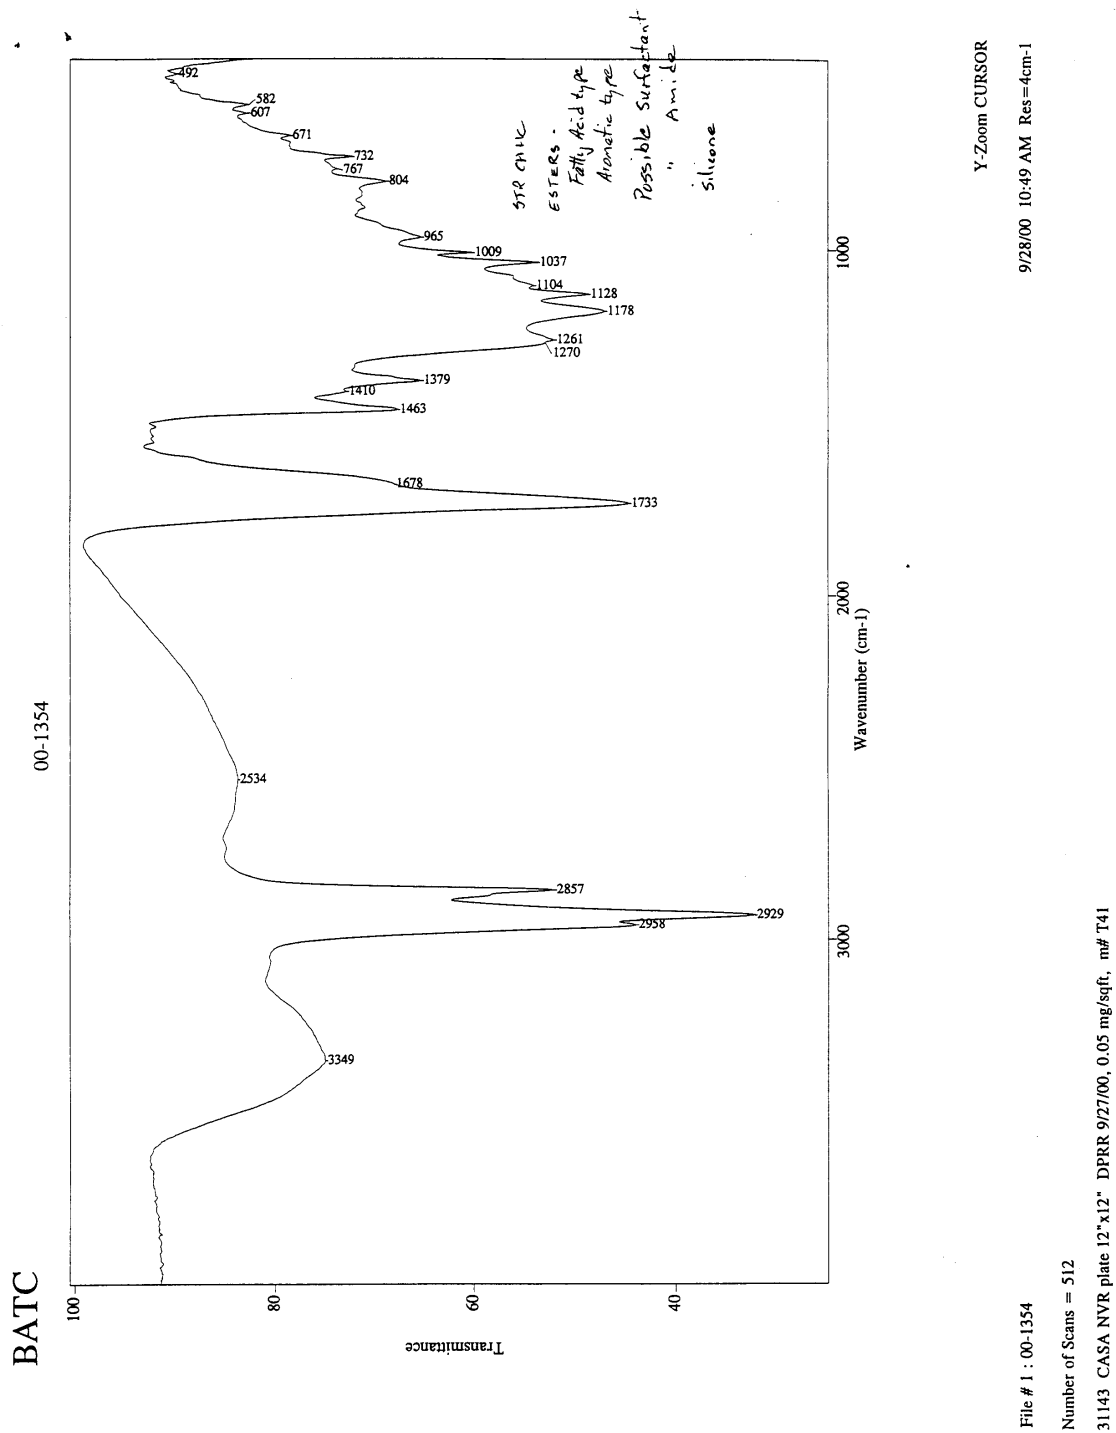
0.05 mg/sq.ft.

IR spectrum # 00-1354 indicated the following components in the residue:

- Straight chain hydrocarbons
- Esters
 - Fatty acid type
 - Aromatic type
- Possible surfactant
- Possible amide
- Silicone
