**COS**  
**Monthly Status Review**  
**June 26, 2002**  
**Ball**

## FUV01 Grid Wire Problem

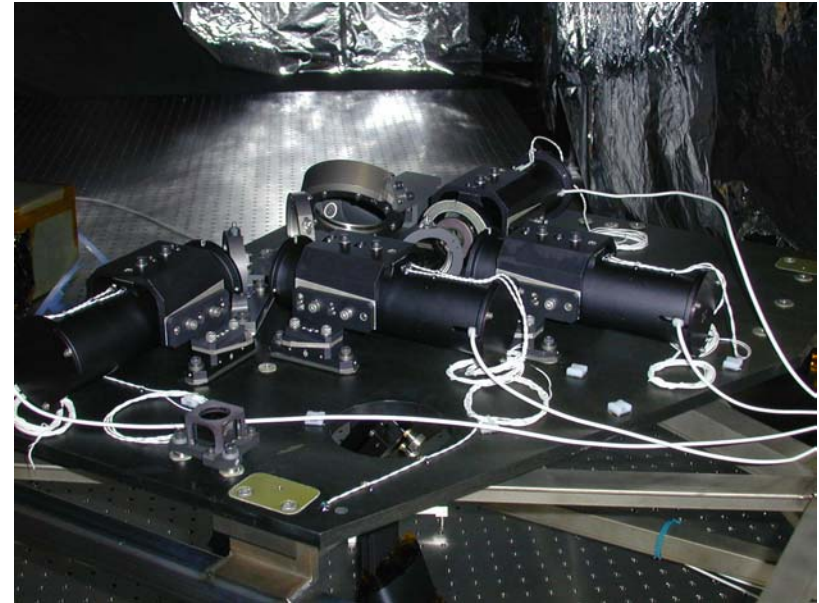
Calibration platform in CU vacuum calibration chamber. All optical components mounted in final locations except for lamps, which are being adjusted in translation. nominal positions.

- Pre-vacuum alignment completed, with all components in nominal positions. Beam splitter and ellipse shims ground and installed.
- Initial active alignment using lamps and PMT complete.
- Vacuum alignment and initial photometric calibration to begin this week.
- NDF selection to be performed this week
- Detailed photometric calibration, staking of components and installation of alignment diode to be performed next week, with earliest delivery to Ball on 5 July, 2002.

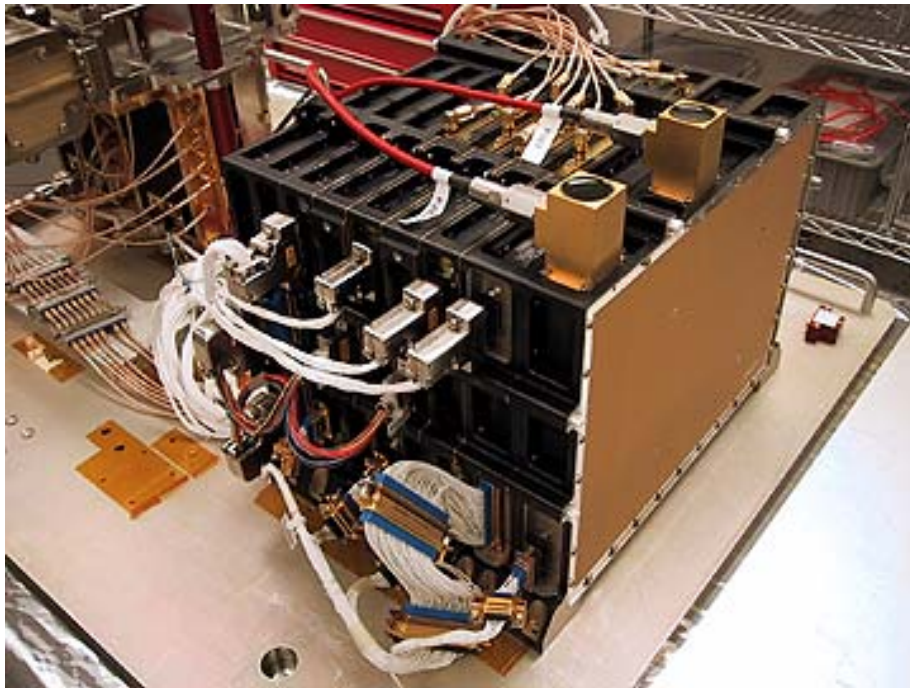
## COS FUV Detector Systems

- Detector DEB
- Detector Head

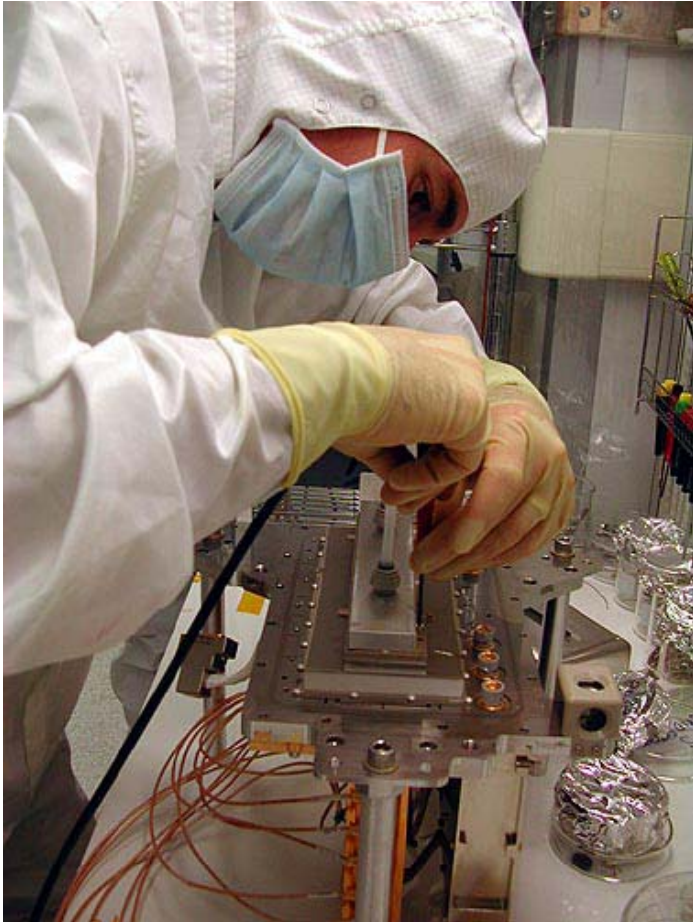
## FUV01 Grid Changeout

- **New Stork-Veco mesh assy installed**
- **Total changeout time ~45min**
- **Constant nitrogen purge used**
- **Post changeout field emission observed!**

- **Diagnosed as mounting hardware**
- **FUV01 grid mount screws changed out**
- **All field emission gone!**
- **Background 10 - 20 events/sec on each side of detector**
