COS
Monthly Status Review
November 6, 2002
NASA/GSFC

FUV02, VHA Seal Leak, Status

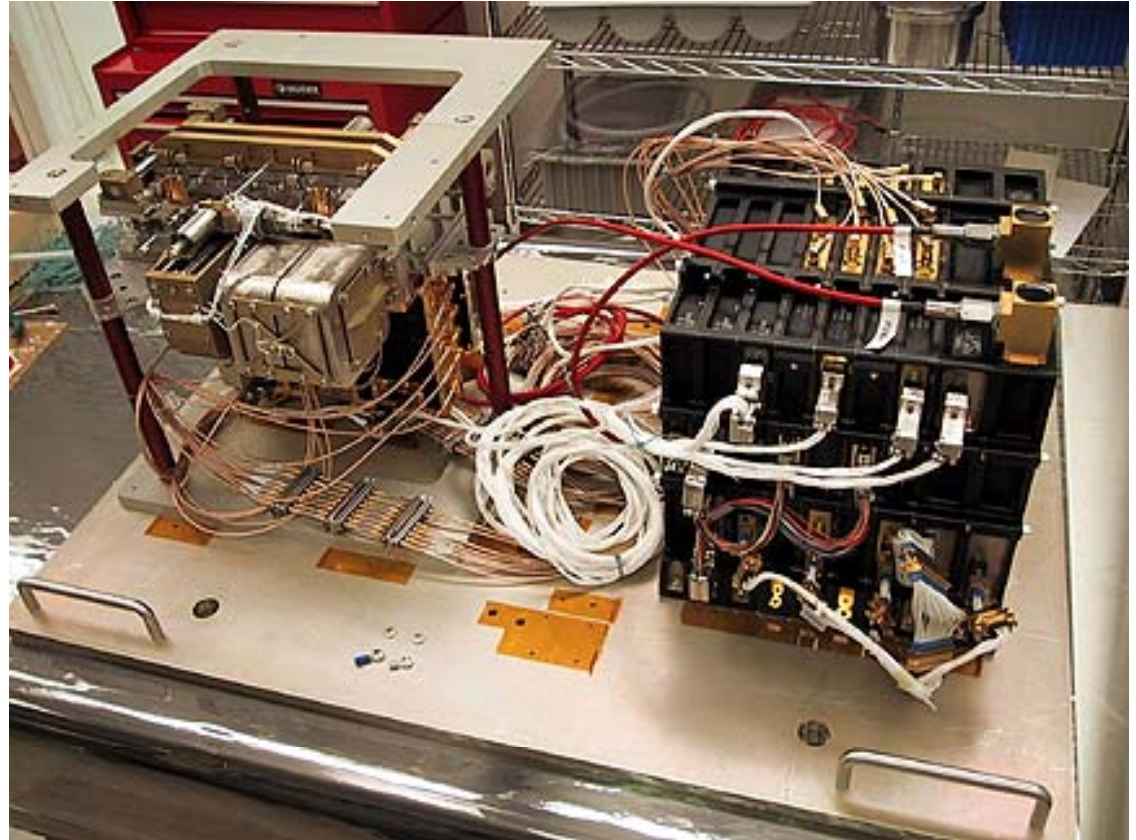
Flight FUV01 Detector System

Completed thermal vacuum at
CU, delivered to Ball 7/31.

Post delivery functional tests
nominal.

Cleanliness certification at Ball
completed successfully.

Alignment tests in done.

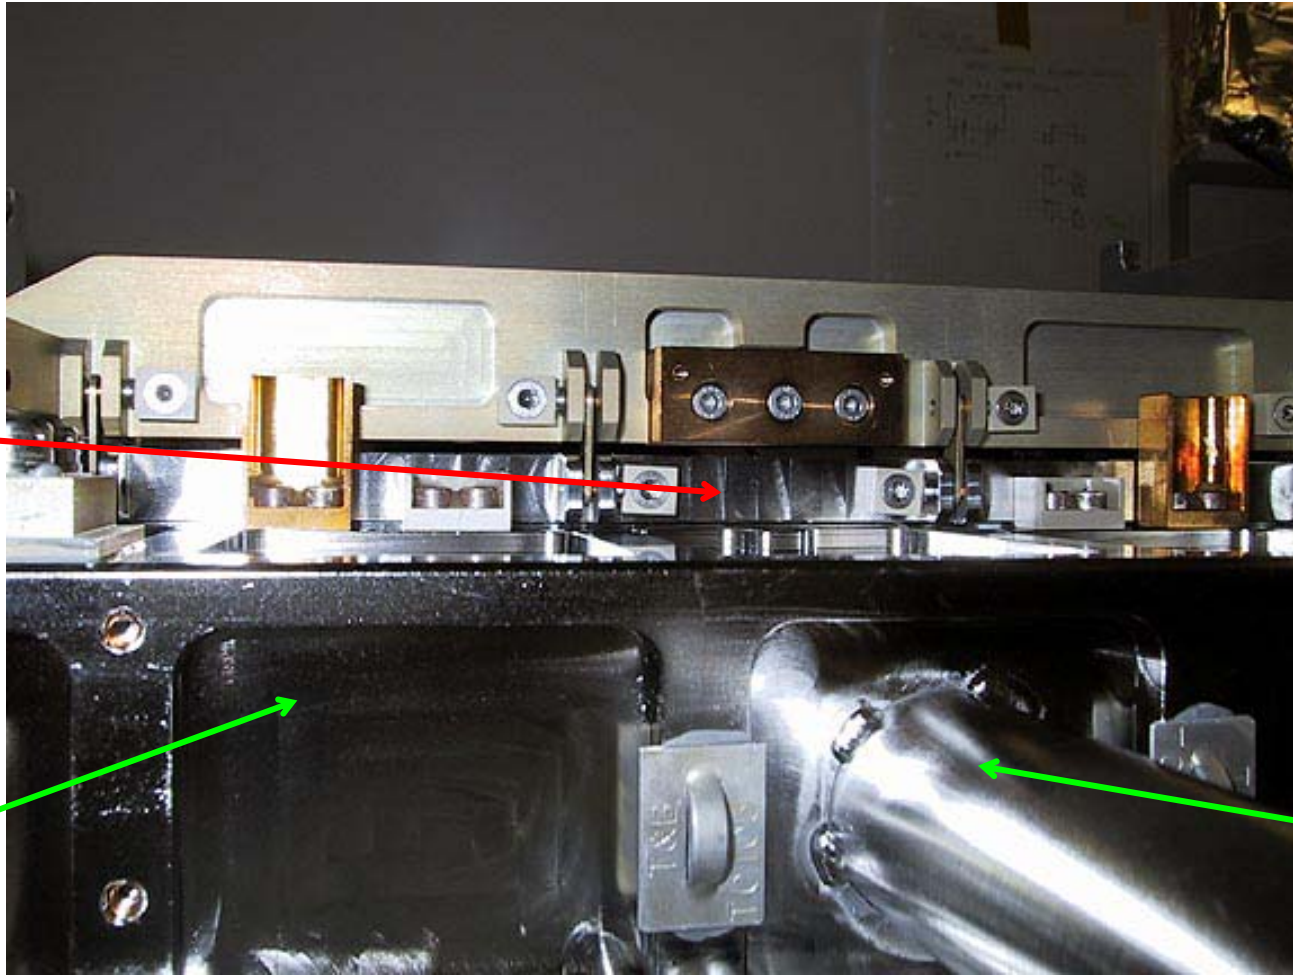
FUV02 Door assembly attached to VHA

Lower (seal)
door

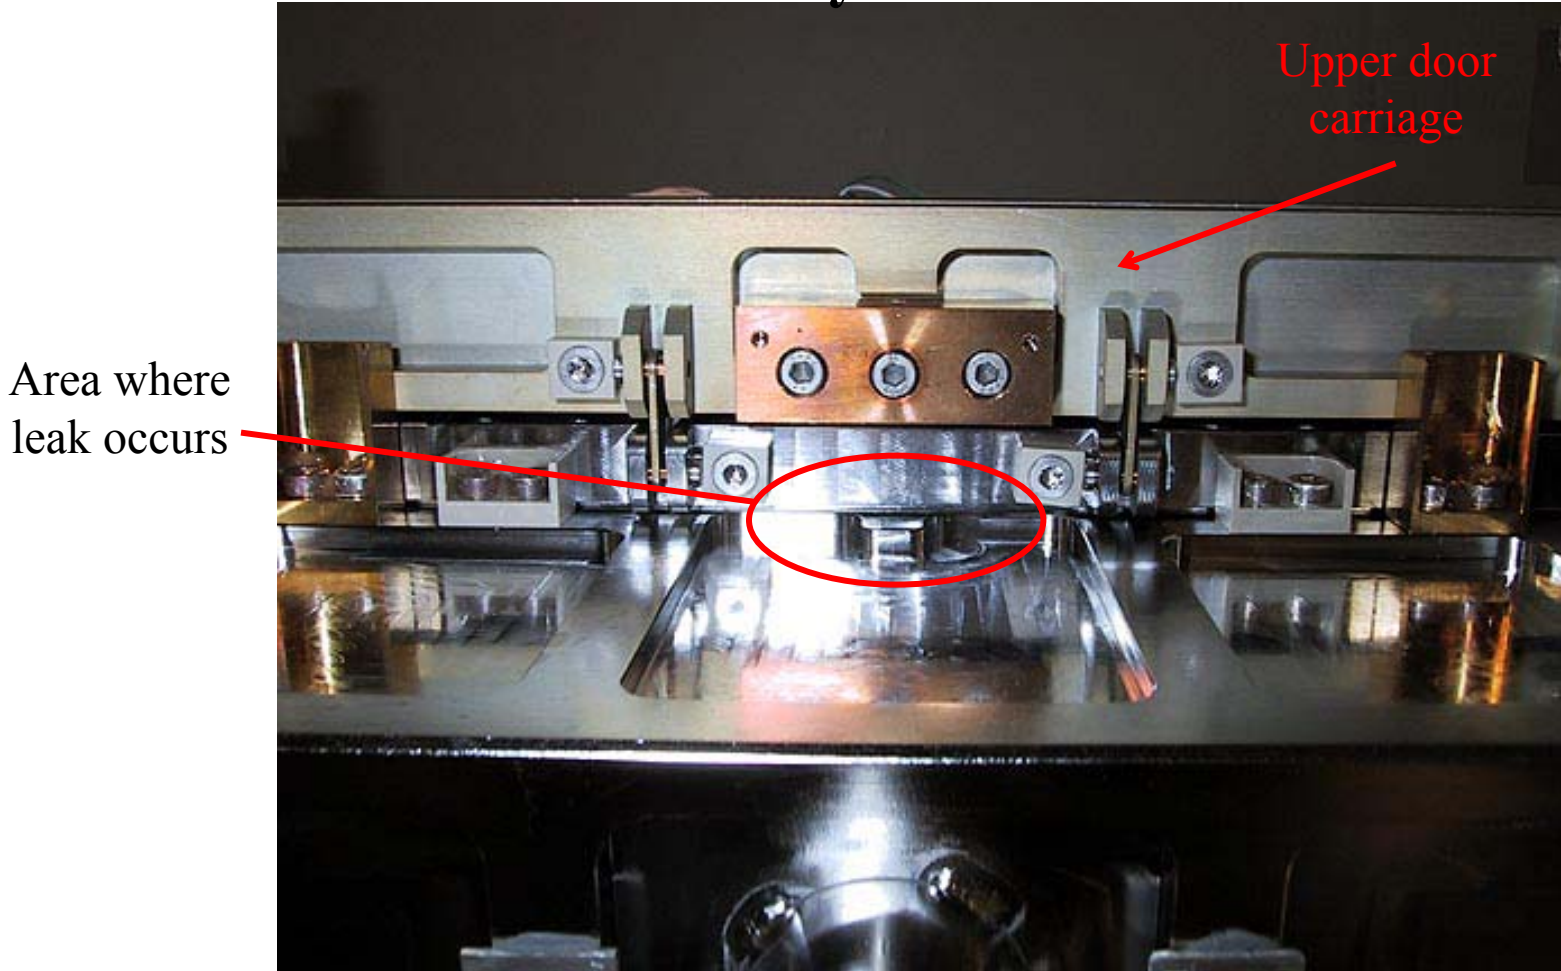
Door assembly attached to VHA - inspection and metrology

Measurement of VHA surface with
& without atmosphere differential

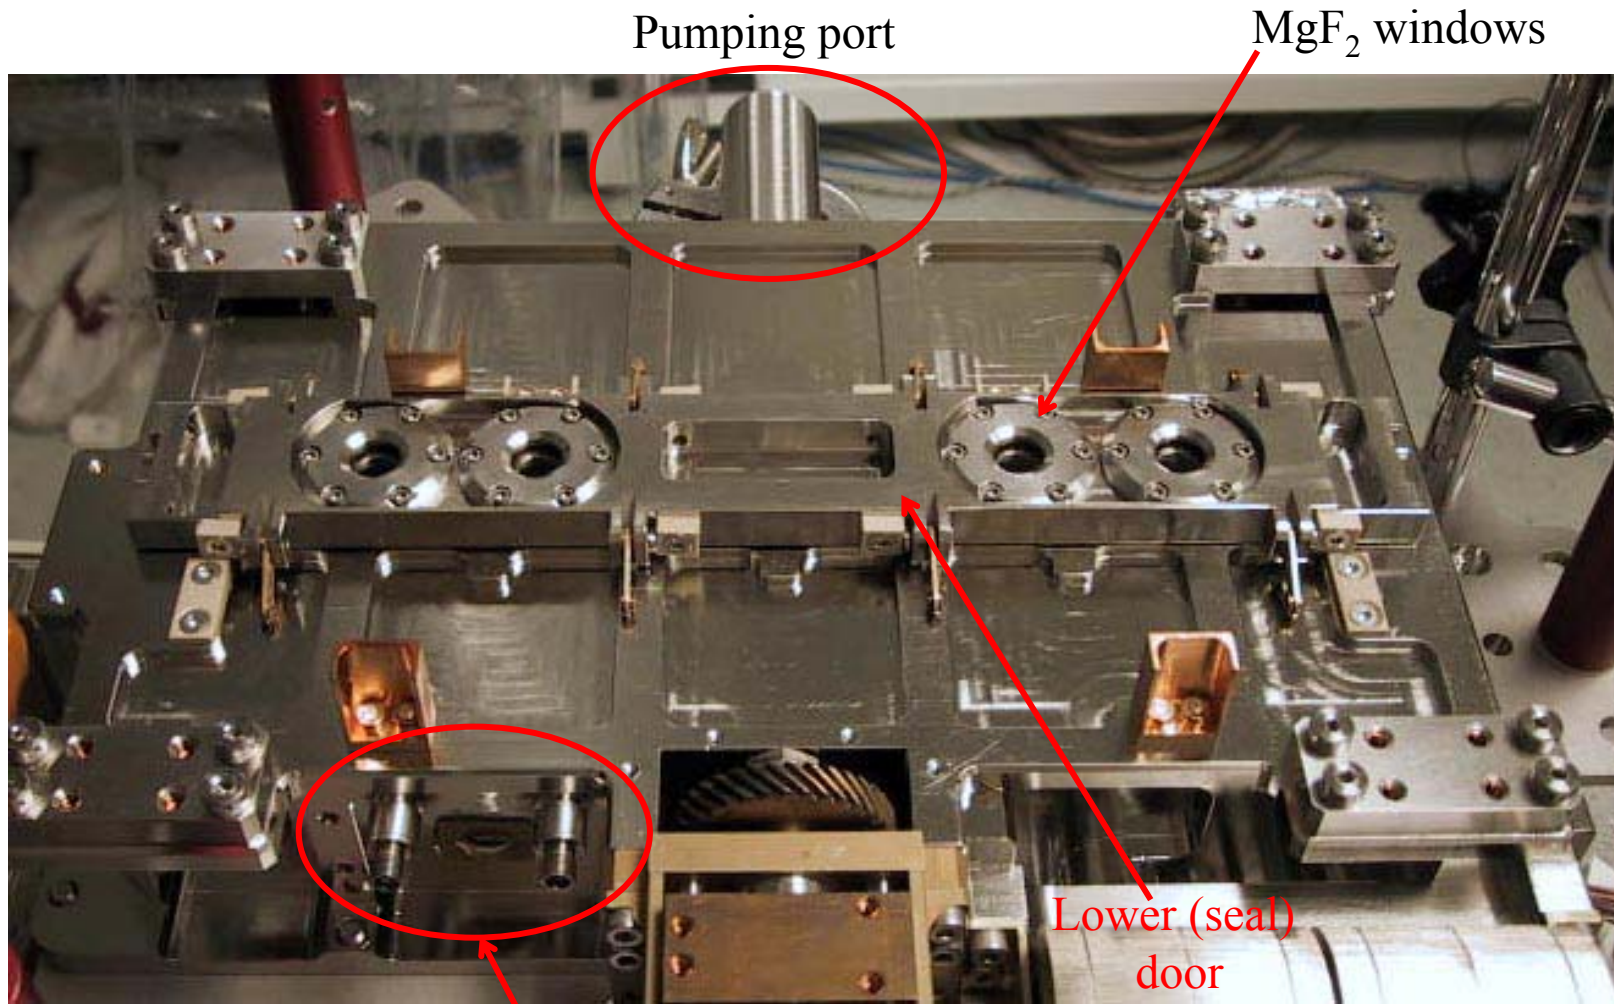
VHA with door mechanism removed

- We have two doors from Ball, FUV01 and FUV02
- Both were measured flat to better than $\sim 0.001''$
- We suspect that the FUV02/ETU VHA distortions were incurred when the pumping ports and SMA feedthroughs were welded in.
- After “o”ring regrease the VHA now seals and there is no leak
- **Door/VHA has accumulated >40 successful operations,**
 - **There is probably a re-distribution of grease on the “o” ring with ops**
 - **Leak appears only at 1 Atm differential, after many operations**

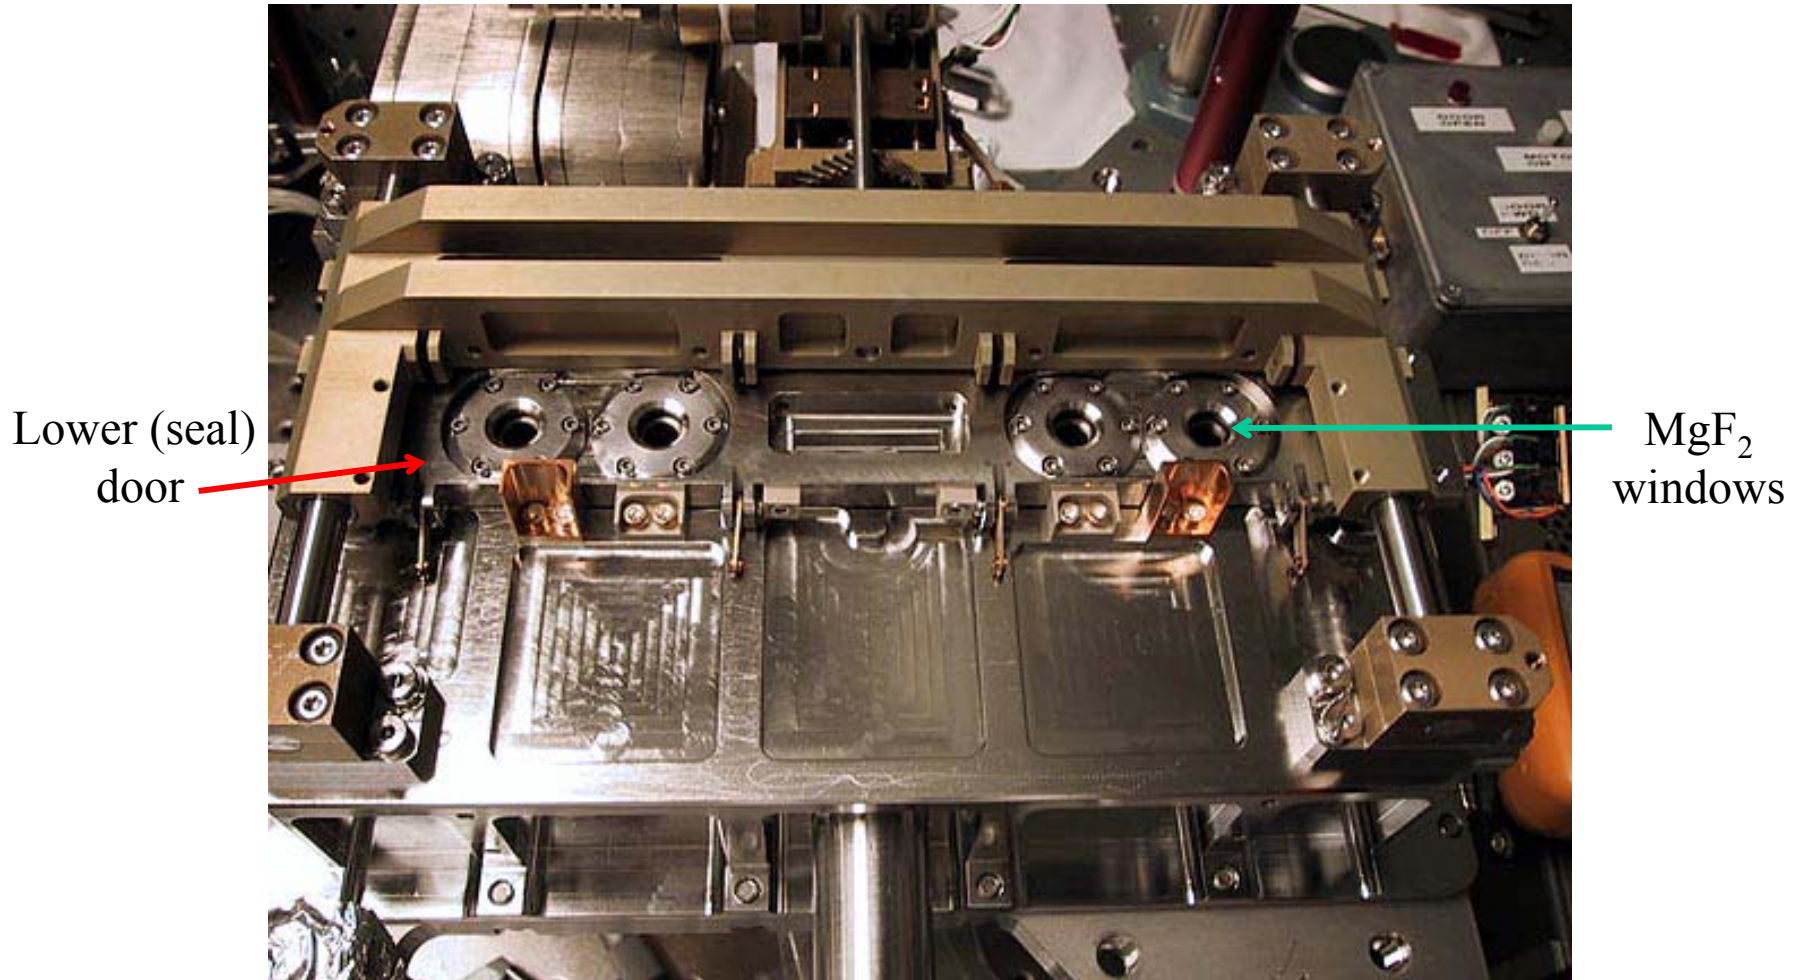
Lower door detached from upper door (links disconnected)
